Dredging-Related Sediment Impacts on Coral Reefs near the Port of Miami Channel

Rachel Silverstein, Ph.D.
Executive Director and Waterkeeper

The Project: Deep Dredge Background

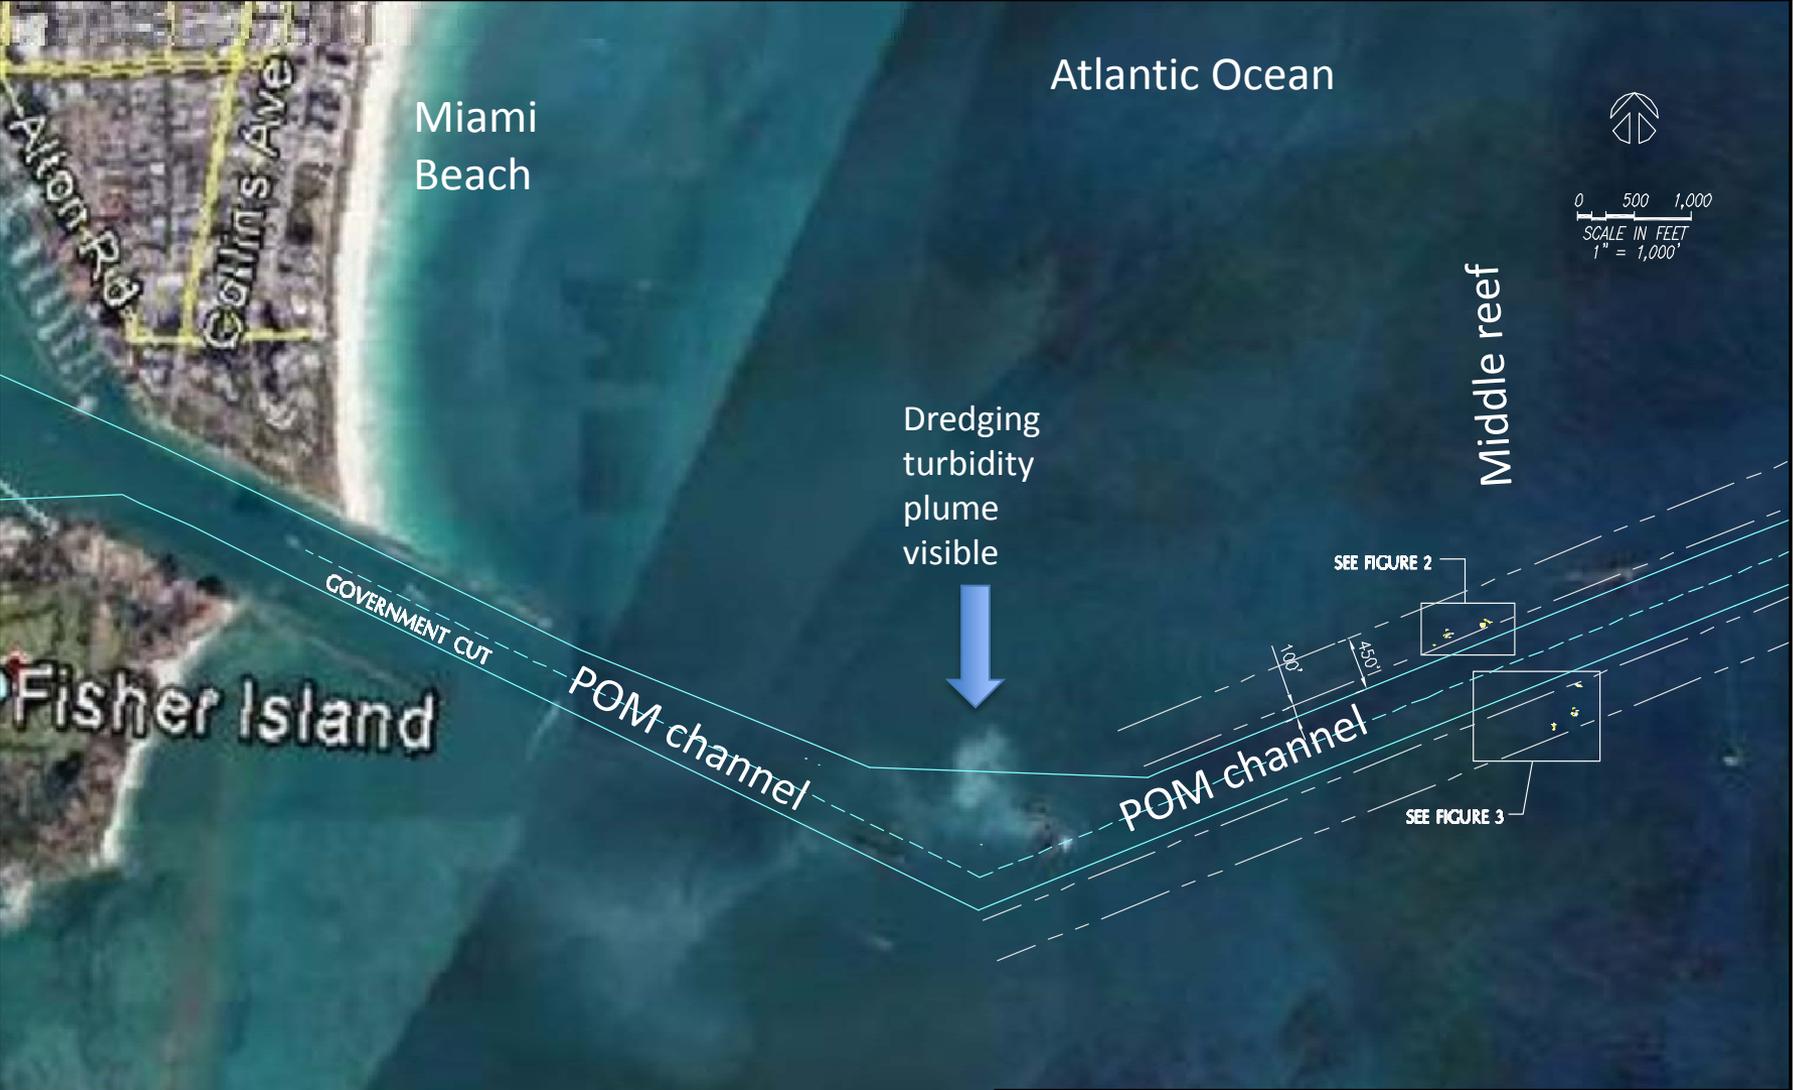
FIGURE 1
ENTRANCE CHANNEL ACROPORA CERVICORNIS MONITORING PROJECT
LOCATION MAP
AUGUST 2014

Shows the reef location near Miami Beach and the location of the Port of Miami shipping channel, within which dredging is occurring offshore.

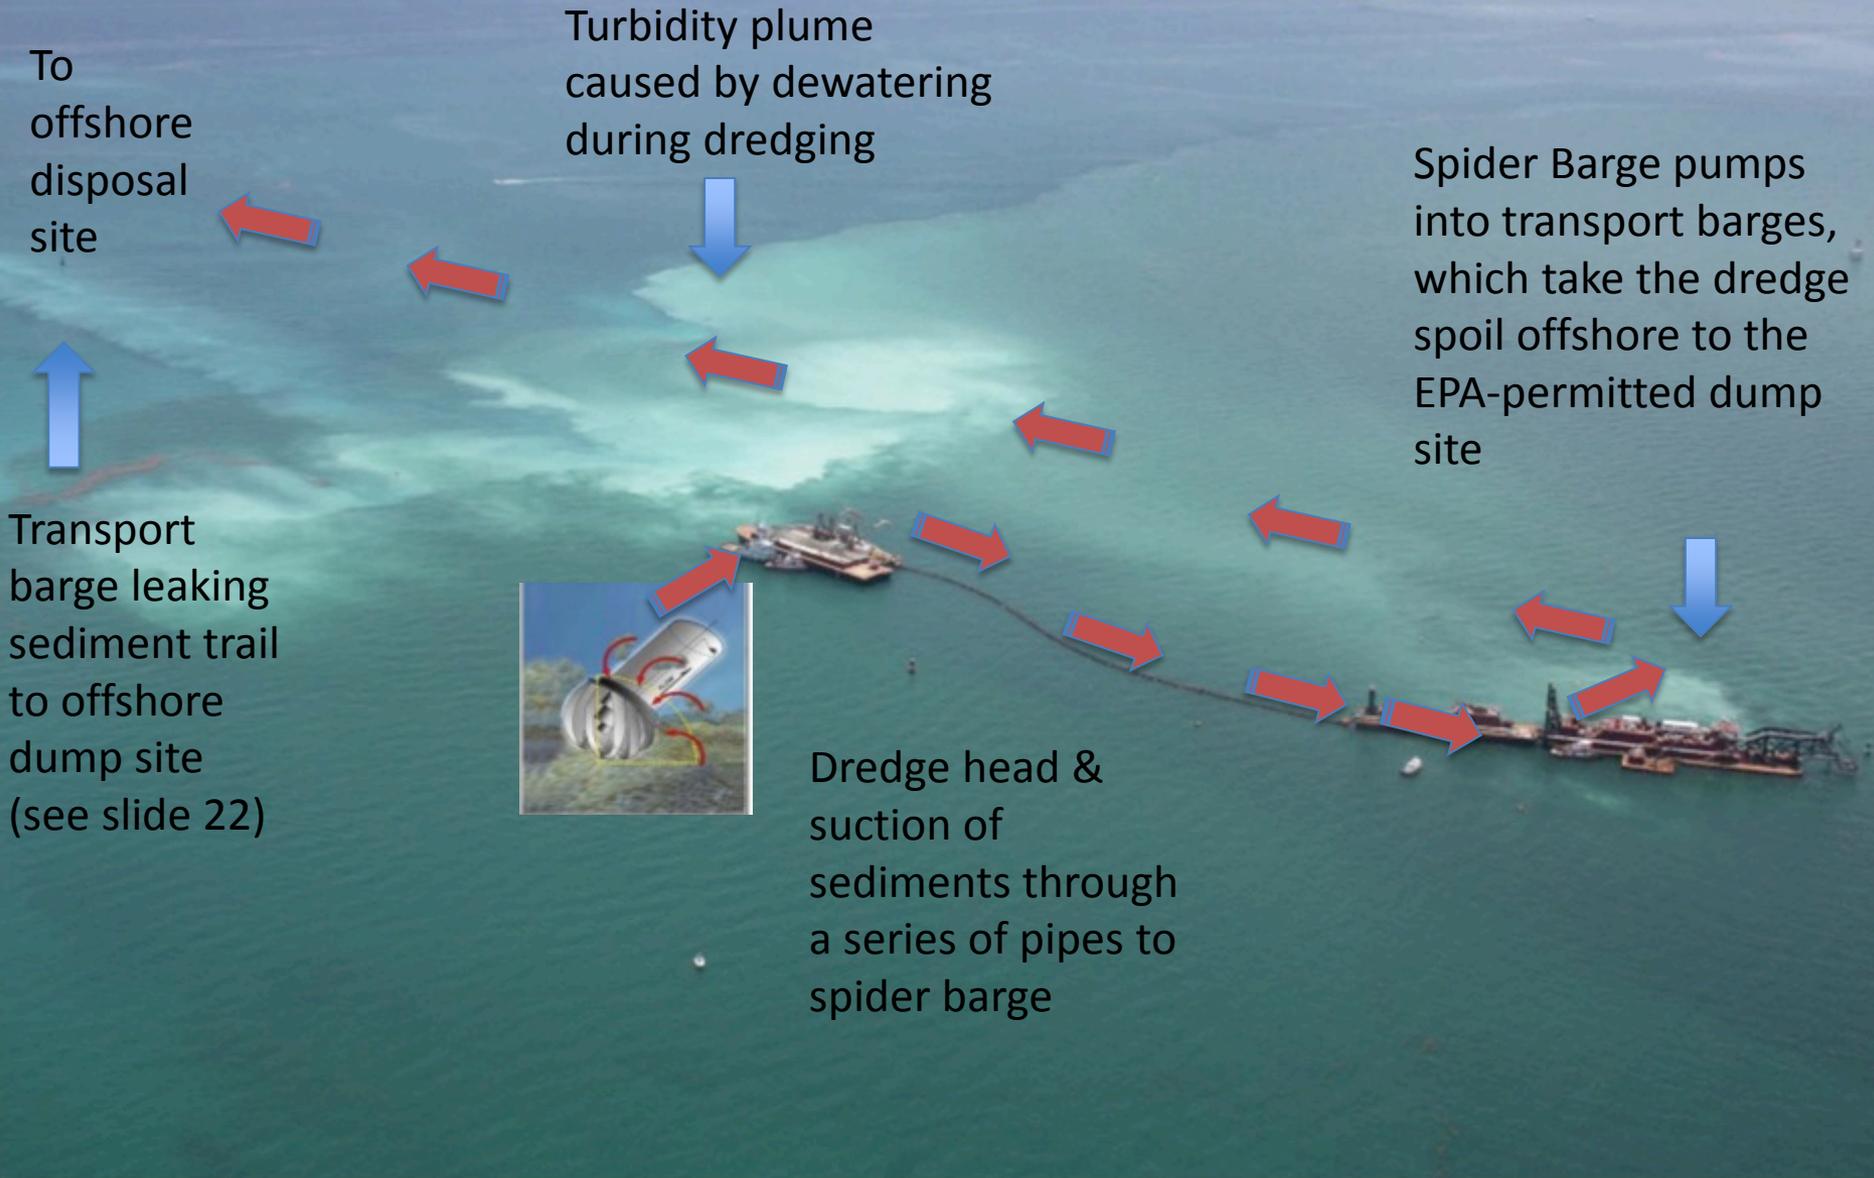
Path of dredge sediments

Dewatering (letting water and fine sediments leak out of transport barges) to reduce load creates massive turbidity (suspended sediments in the water, which fall out of suspension and onto the reef and smother it)

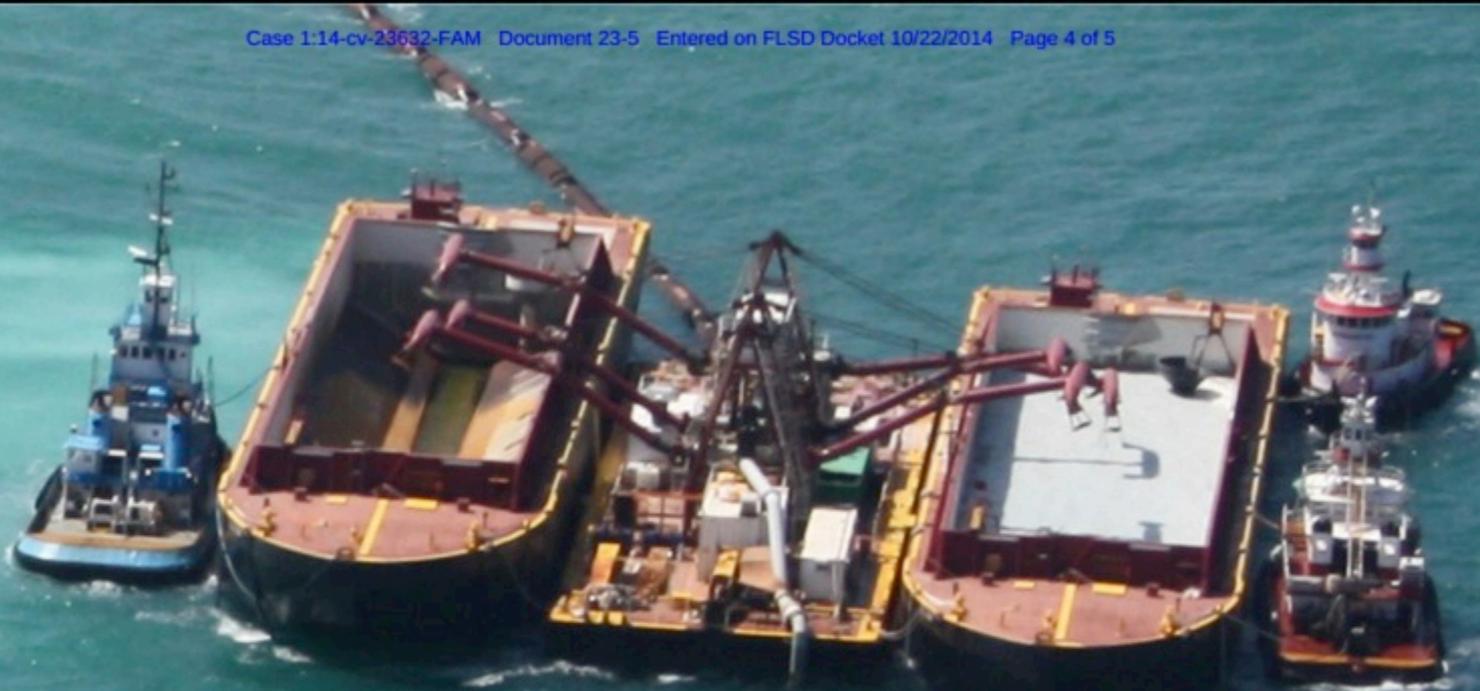
Massive, widespread sedimentation on top of coral has occurred, as documented by Corps contractors, DEP, NOAA, DERM, and BBWK

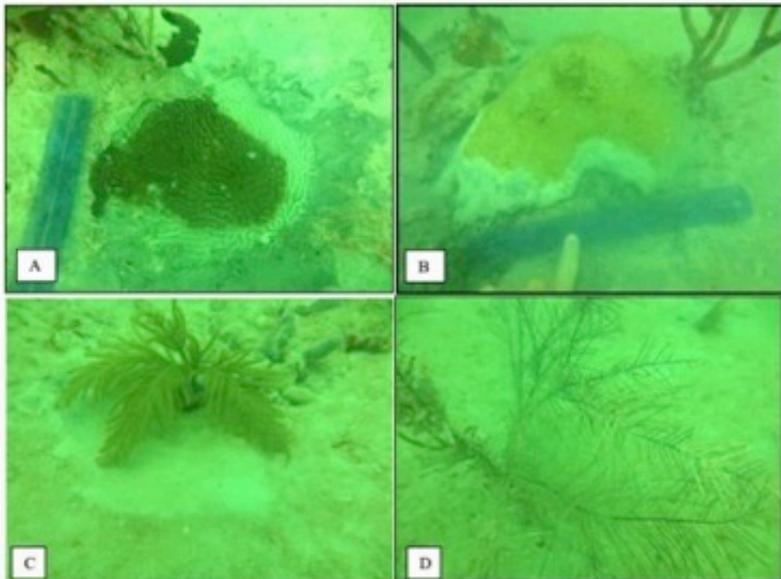
Site A: This site is a shallow-colonized pavement reef located approximately 150ft north of the 'elbow' of Government Cut channel. This site is in 23 ft of water. This low relief hard bottom is inhabited by numerous octocoral species, scleractinians, and sponges. Wide view photographs were not possible due to poor visible from sediment plume. Turf algae was partially visible and ~ 1cm layer of fine sediment was seen on hardbottom. Heavy sedimentation was observed on scleractinians, octocorals, and sponges. Sediment accumulation was observed along the base of many scleractinians. Wafting accumulated sediment from the colonies revealed recent mortality (~4-6cm of coral skeleton from colony edge) on many scleractinians (Figure 7A, B). The holdfasts of a few octocorals were buried and the branch tips were rubbing against the sediment layer on the hard bottom (Figure 7C). Some octocorals were observed with heavy mucus production (Figure 7D).

Figure 7. Benthic habitat and coral stress at Site A. A) *Meandrina jacksoni* colony with exposed recent mortality from sediment accumulation; B) *Solenastrea bournoni* colony with exposed recent mortality from sediment accumulation; C) Octocoral with buried holdfast and branch tips braising the sediment covered hard bottom; D) Octocoral with heavy mucus production.

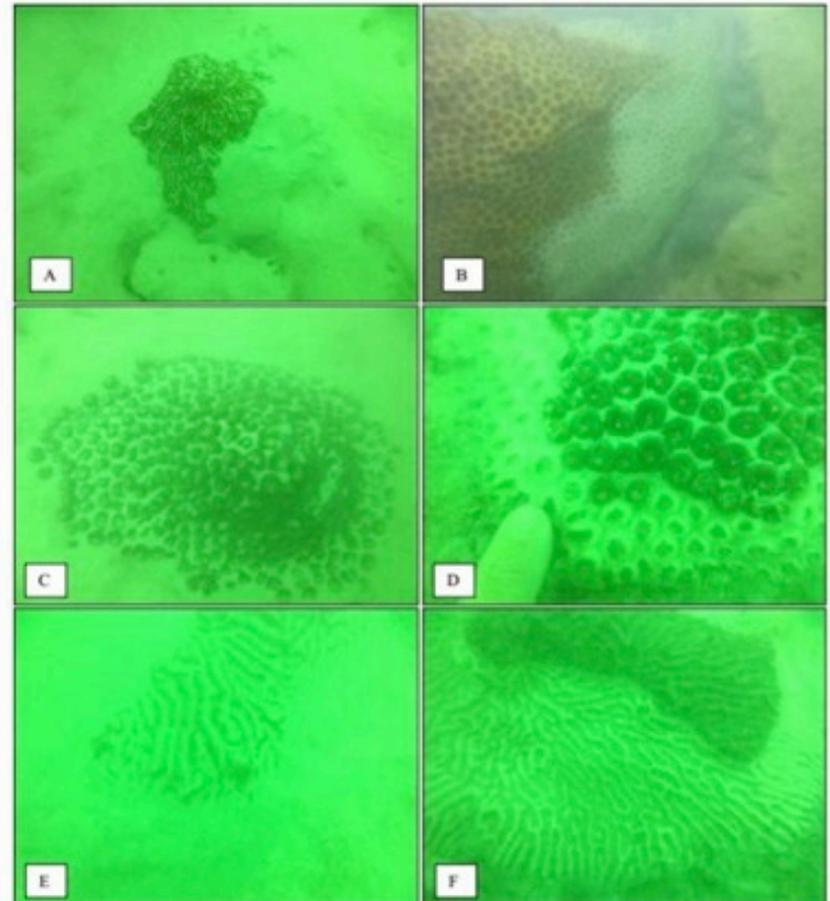
Figure 6. Benthic habitat and coral stress at Site B. A) *Solenastrea bournoni* with heavy sedimentation; B) Same *S. Solenastrea* colony in Figure 6A with exposed recent mortality from sediment accumulation; C) *Montastraea cavernosa* with heavy sedimentation; D) Same *M. cavernosa* colony in Figure 6C with exposed recent mortality from sediment accumulation; E) *Meandrina jacksoni* with heavy

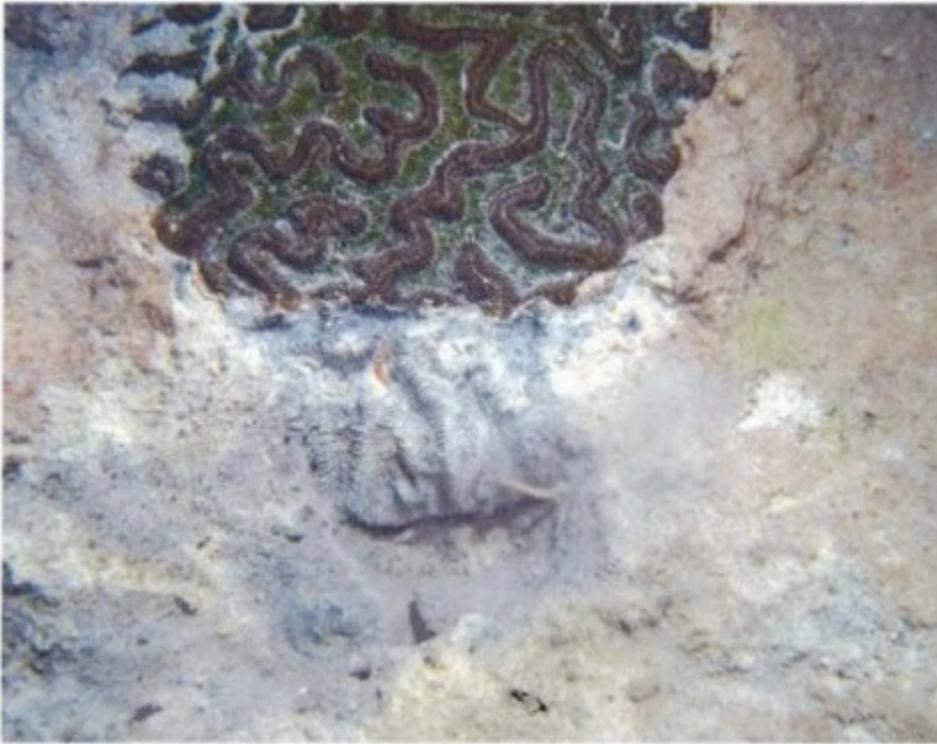
Figure 11. The same colony of *Colpophyllia natans* after sediments were removed from the base of the colony. Considerable part of the colony is dead due to the accumulation of sediments at its base.

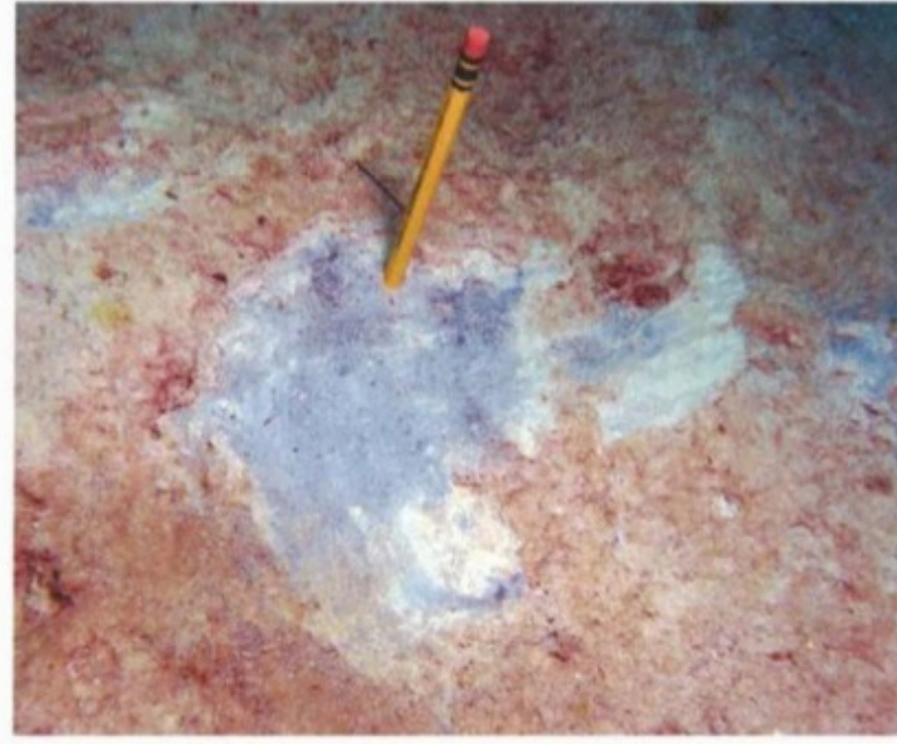
Figure 9. Sediments that covered practically entire area more than 100 m from the channel and southward from monitoring sites HBS3 and HBS4 become anoxic in less than 1 cm below the surface. Notice that almost all surface of recently accumulated fine sediments was covered with cyanobacterial mat.

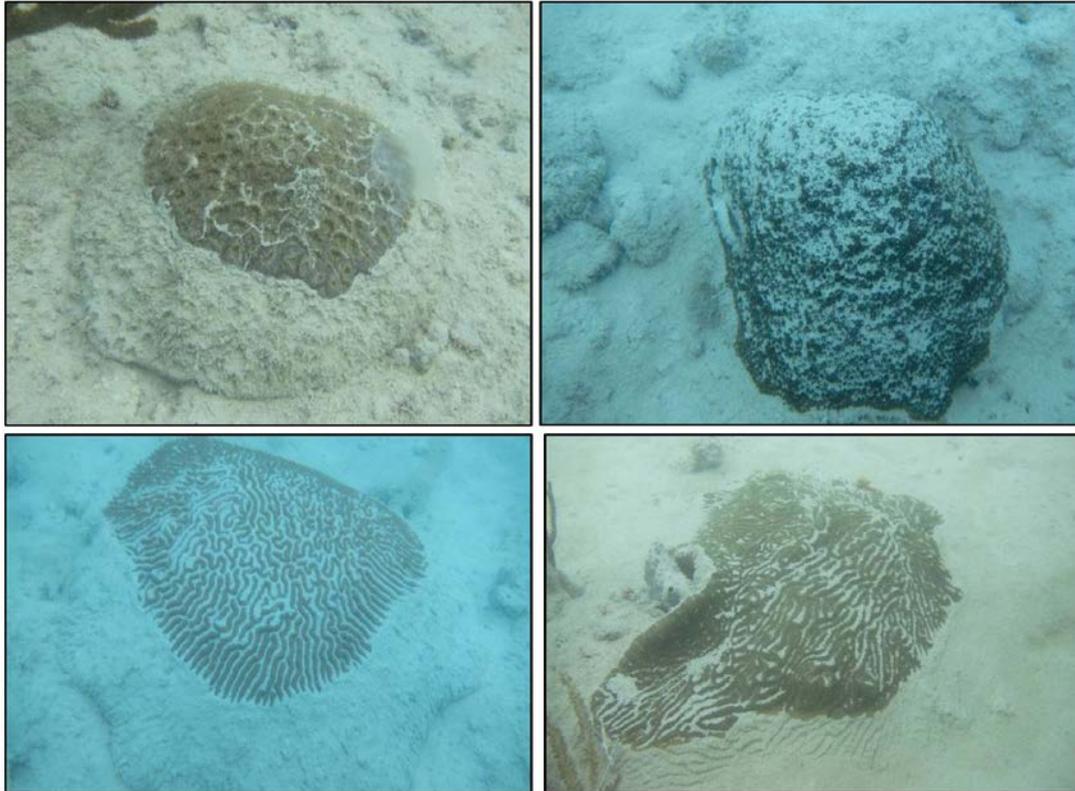
Figure 6: Accumulation of sediment on corals (and resultant partial mortality of basal portions of the colonies) in areas adjacent to the dredging. The colony of *Montastraea cavernosa* on the top left has its tentacles out and is actively producing mucus to remove the sediment. This sediment then accumulates on the lower section of the colonies causing mortality.

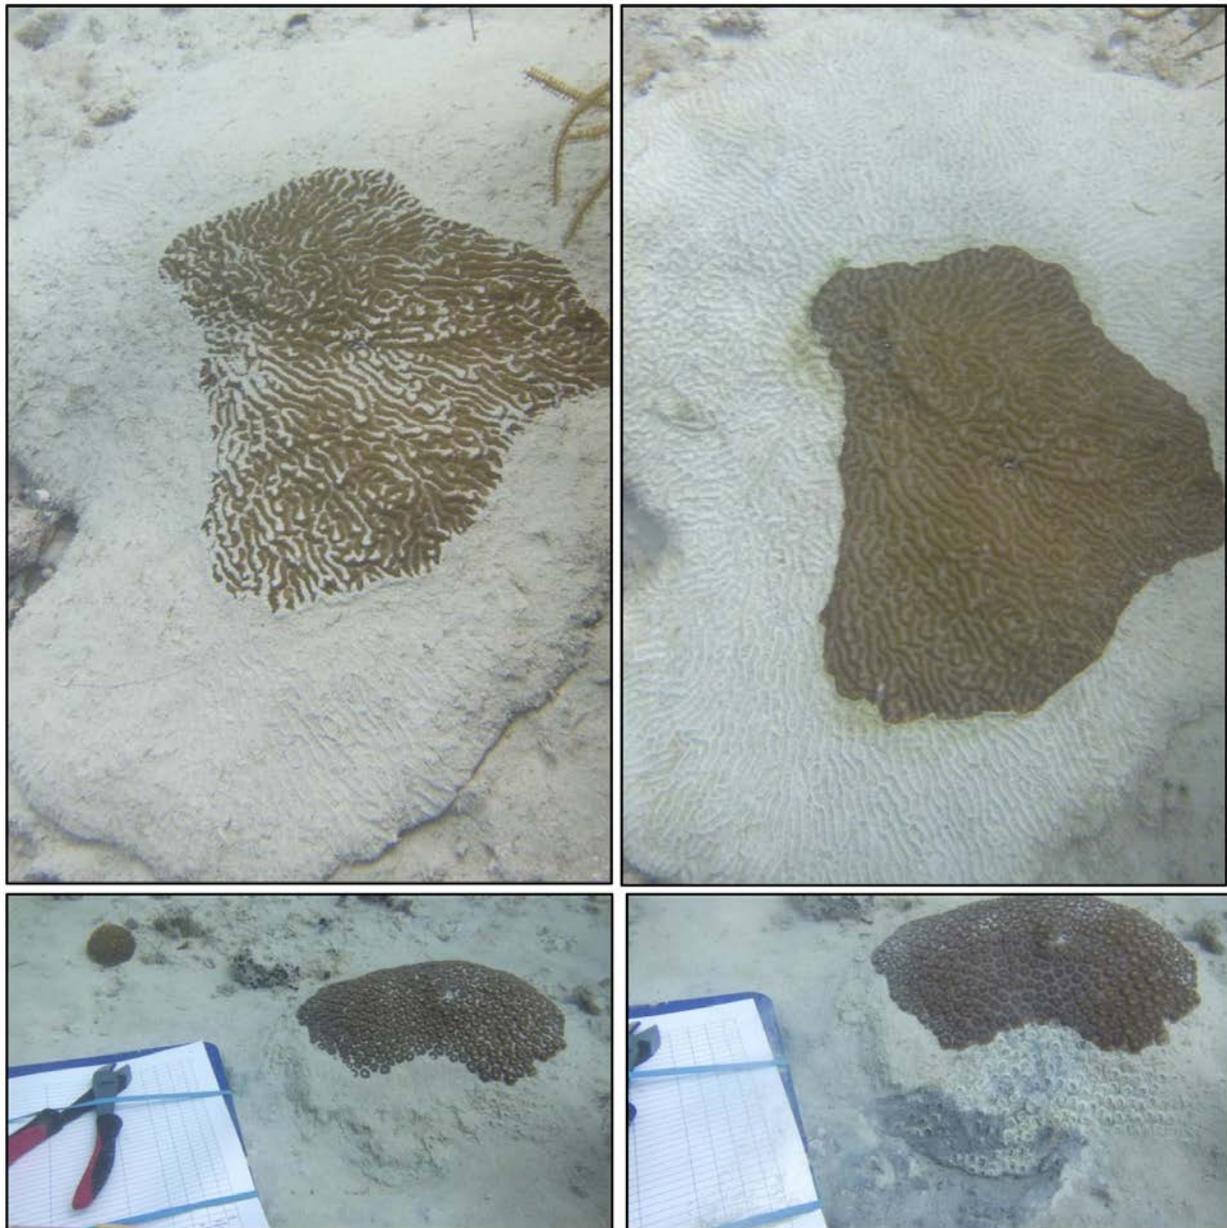
Figure 7: Coral colonies before (left photos) and after (right photos) divers cleared sediment from the corals showing accumulation and recent mortality (exposed white skeleton) along the lower portions of the colonies as a result of accumulation of fine and clay-like material (sedimentation)

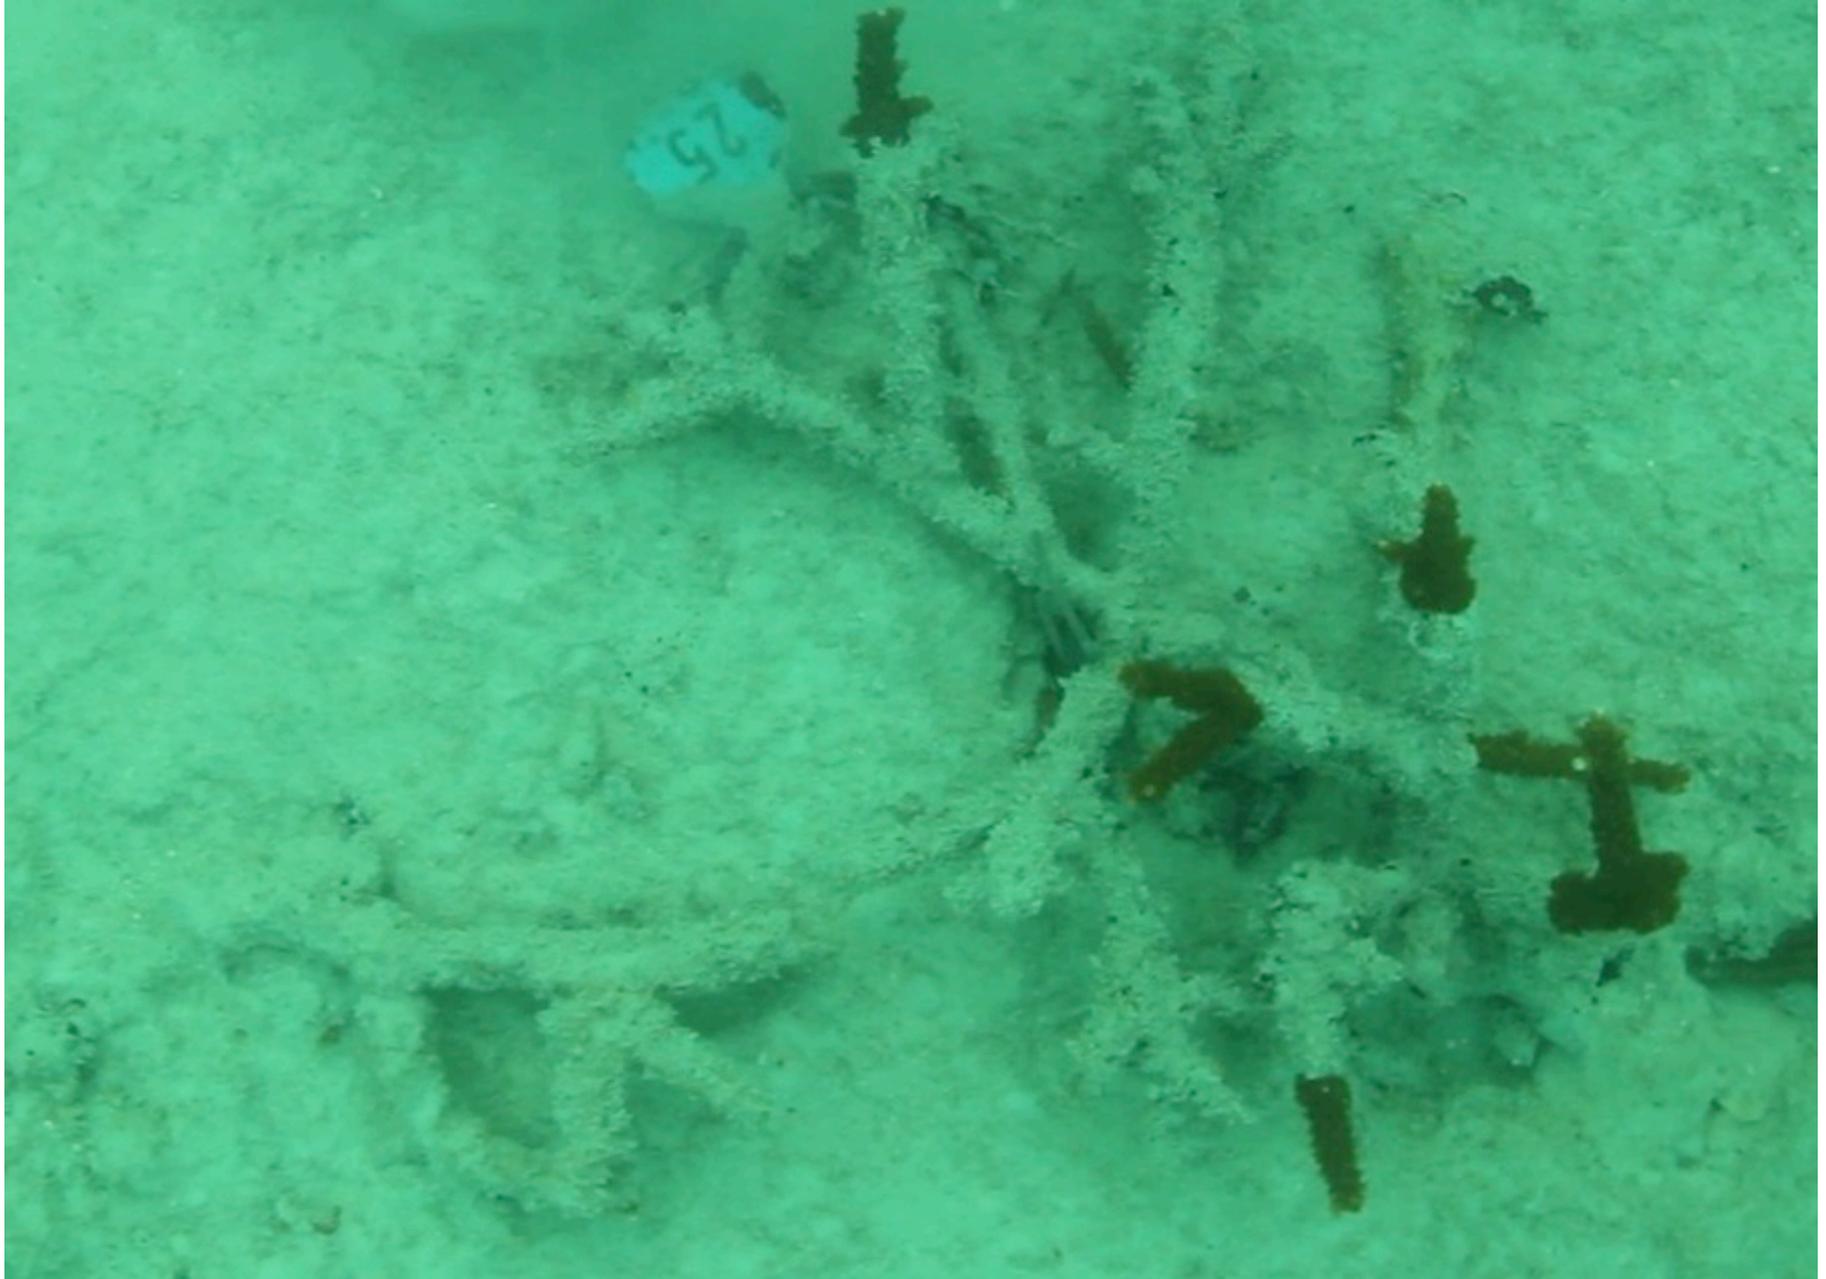
BBWK photo, middle reef relocation area, 1/14/15
Dead staghorn coral

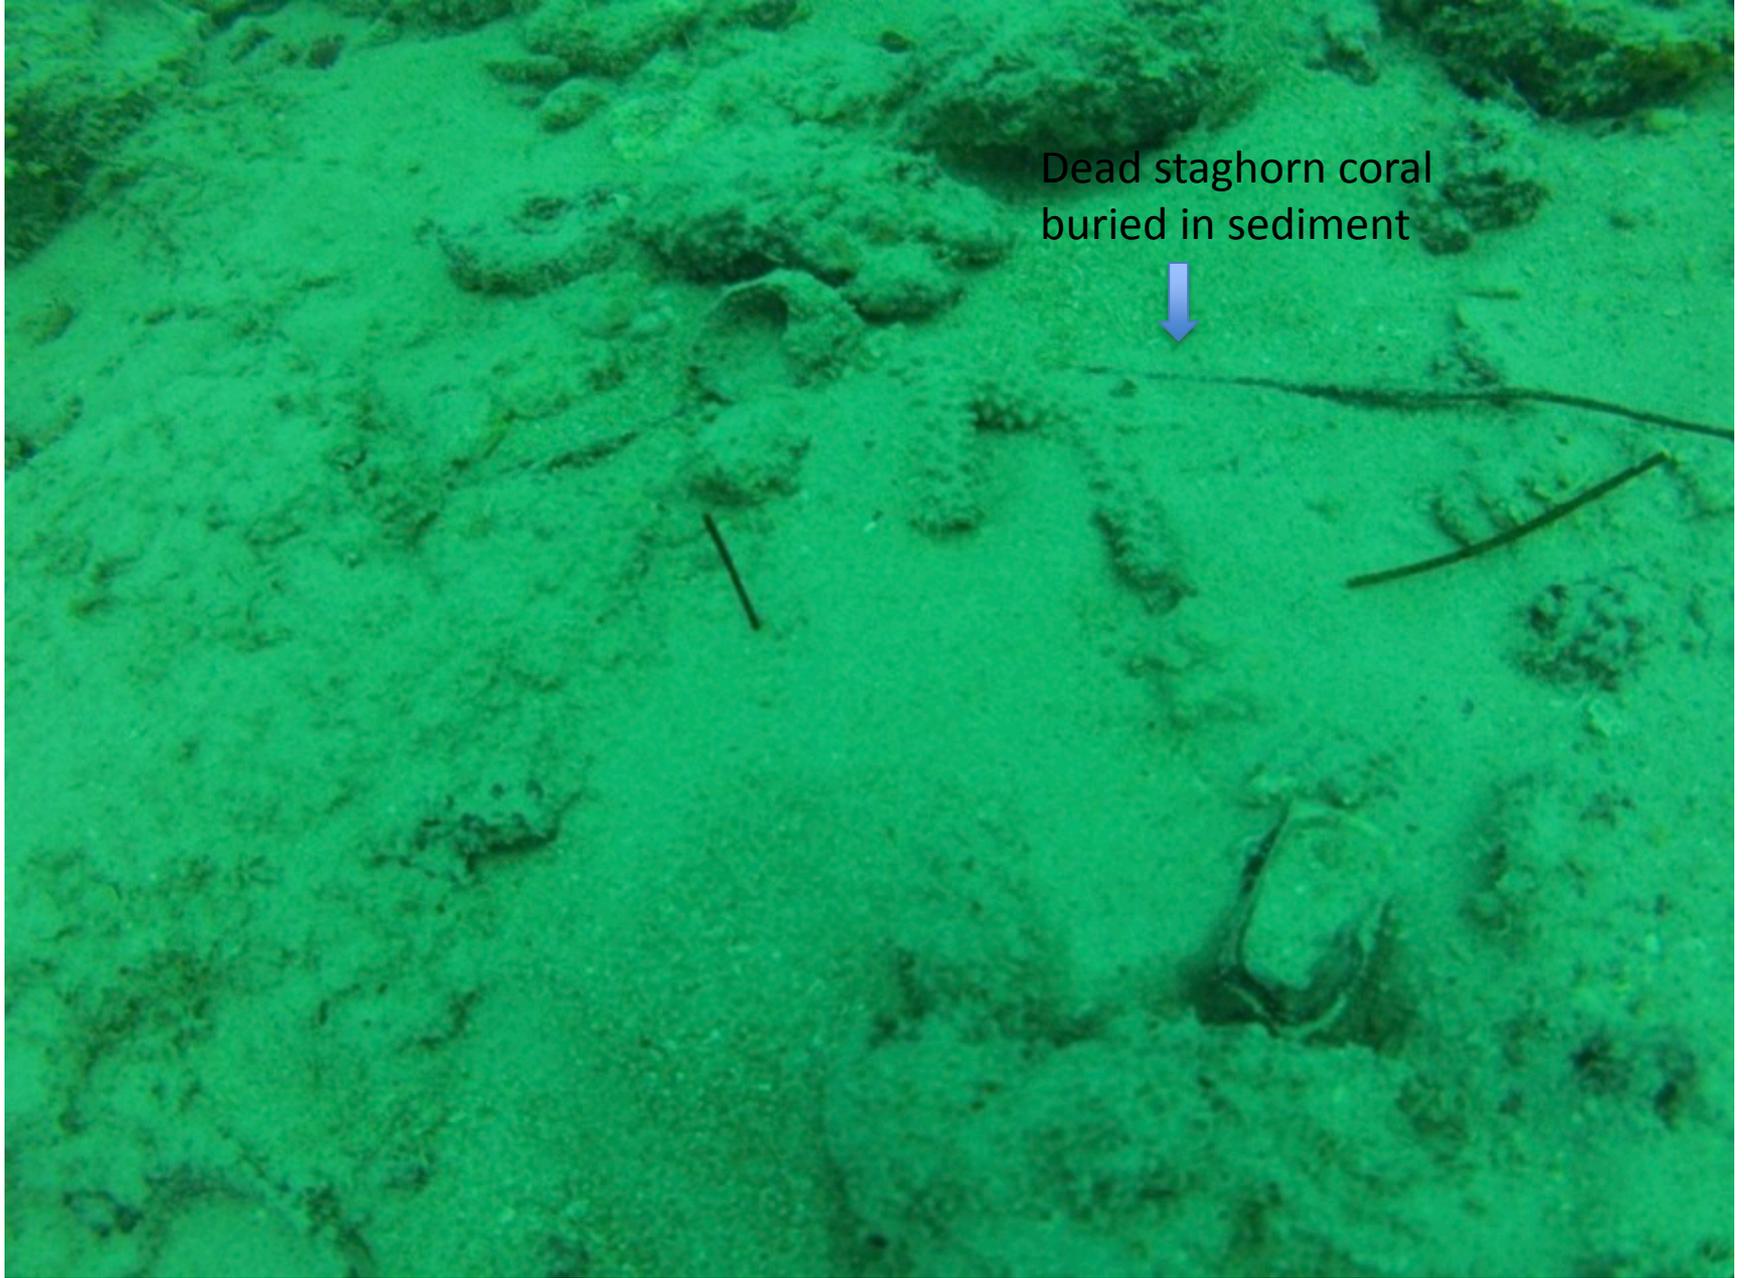
Dead staghorn coral
buried in sediment

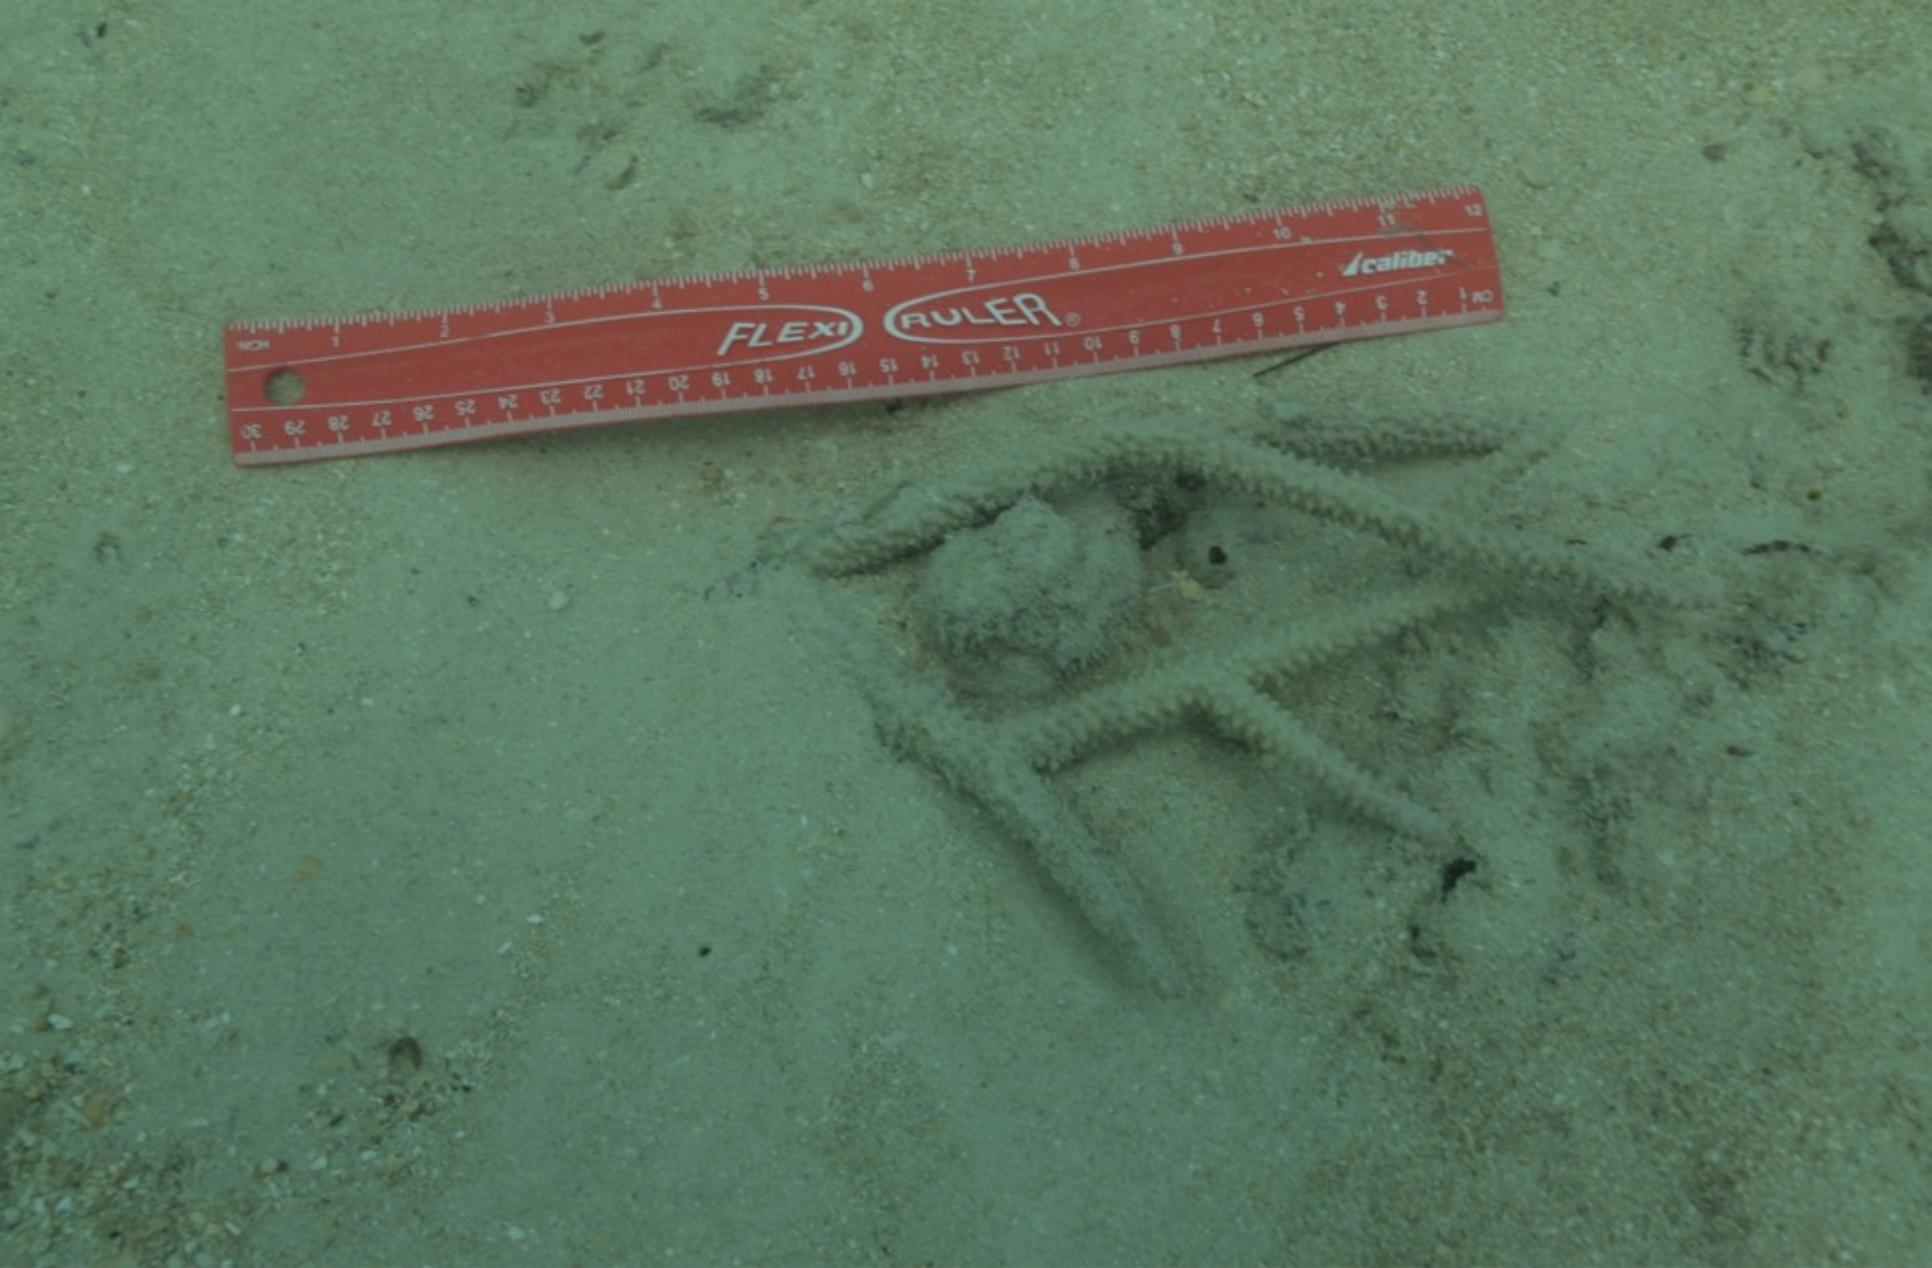
BBWK photo, middle reef, 1/30/15
Dead staghorn coral

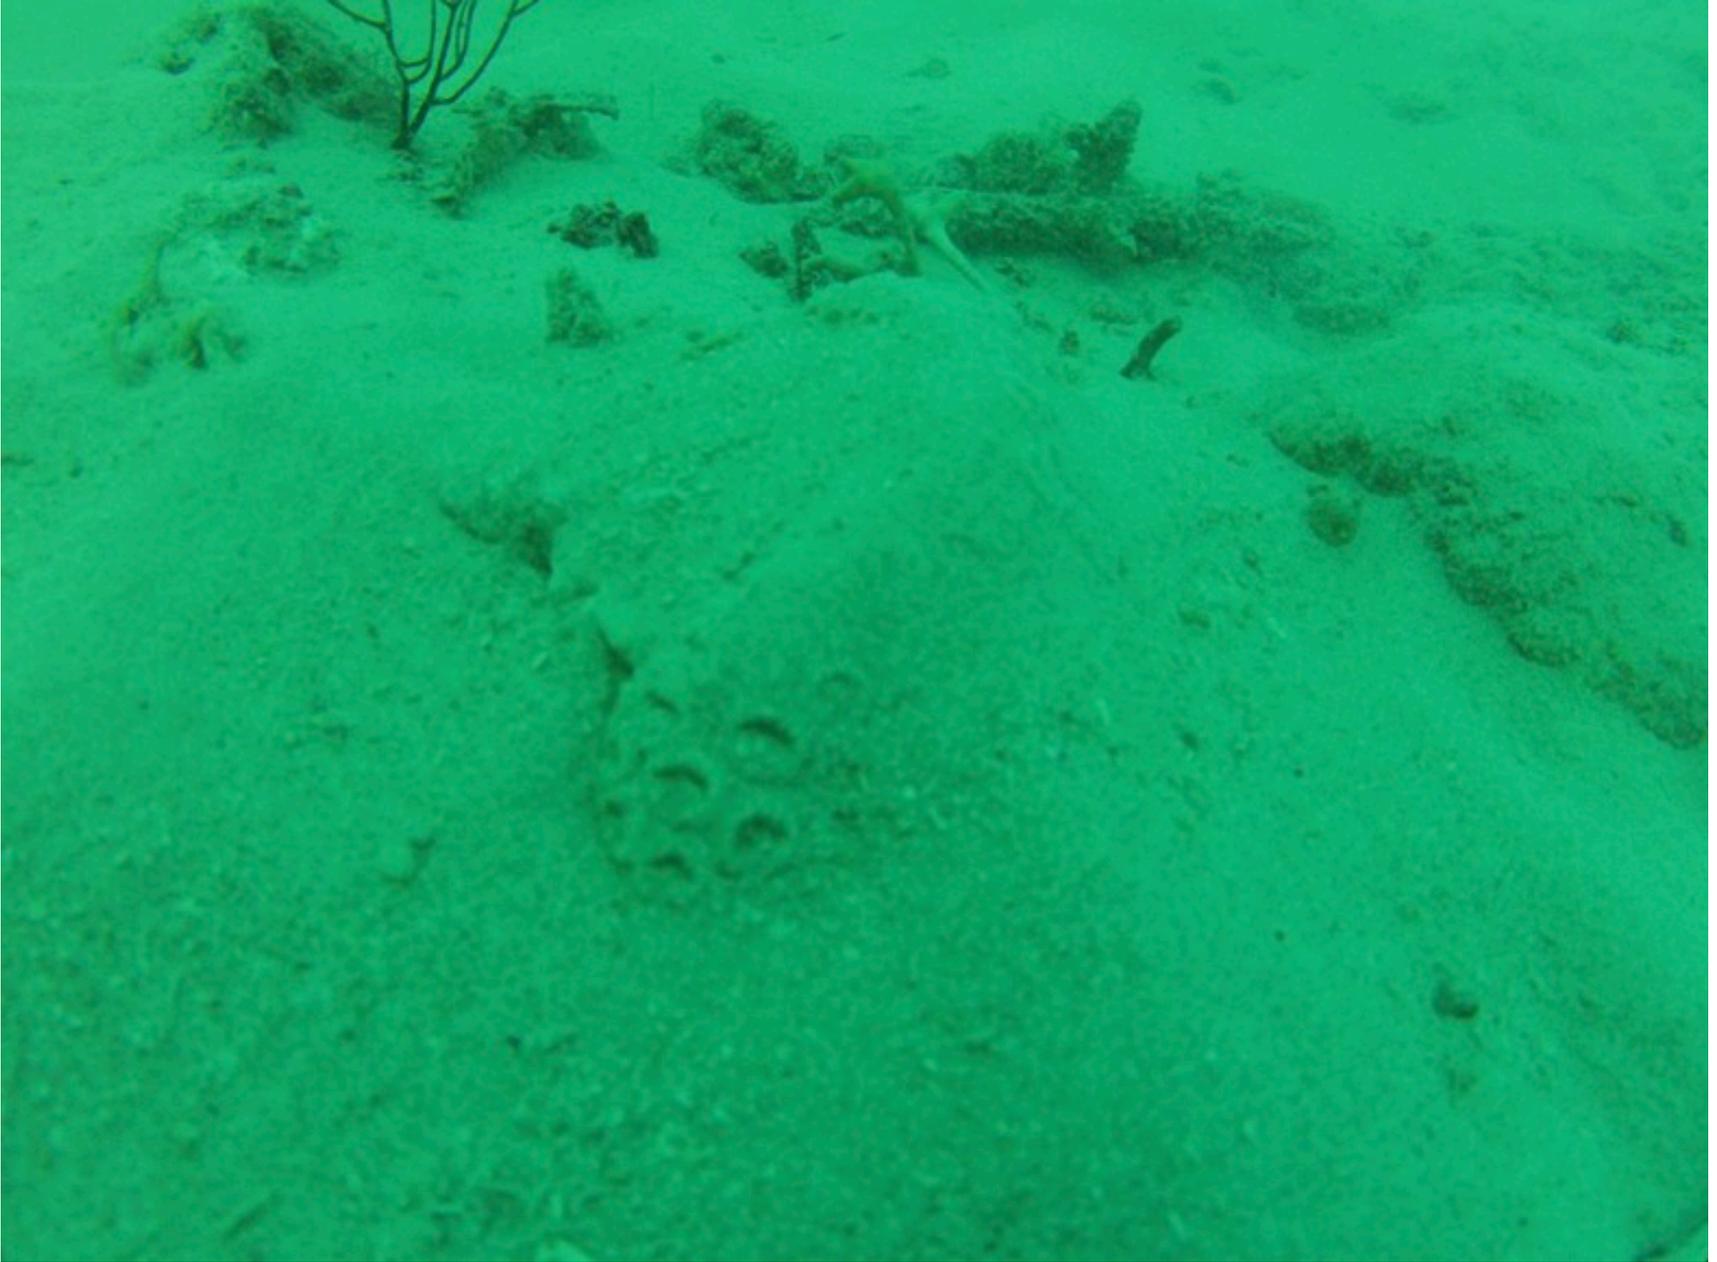
BBWK photo, middle reef, 1/30/15
Buried *Montastraea cavernosa* coral

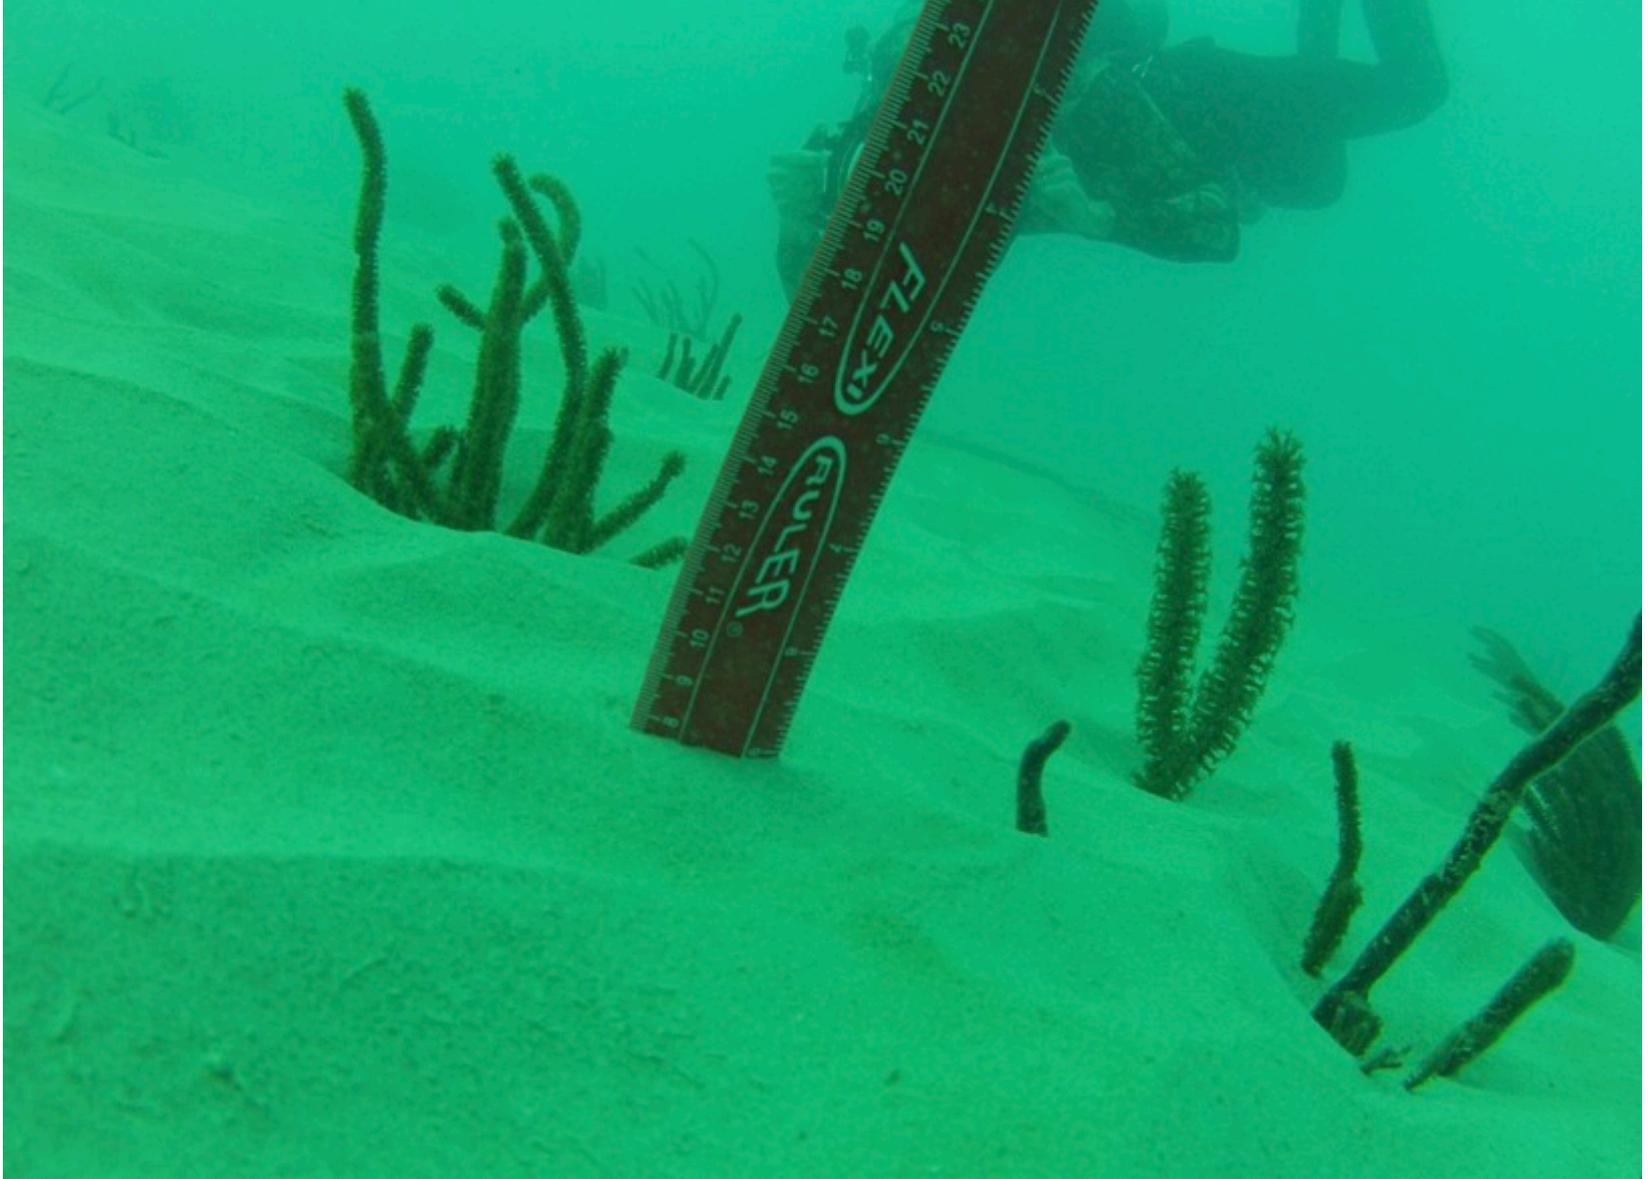
BBWK Photo 1/30/15

Deep sediments still cover the reef 7.5cm deep. Only the tops of gorgonians (sea whips) are exposed. A layer of natural sand covers the clay-like, fine, anoxic sediment below
