Dredging-Related Sediment Impacts on Coral Reefs near the Port of Miami Channel

Rachel Silverstein, Ph.D.
Executive Director and Waterkeeper

The Project: Deep Dredge Background

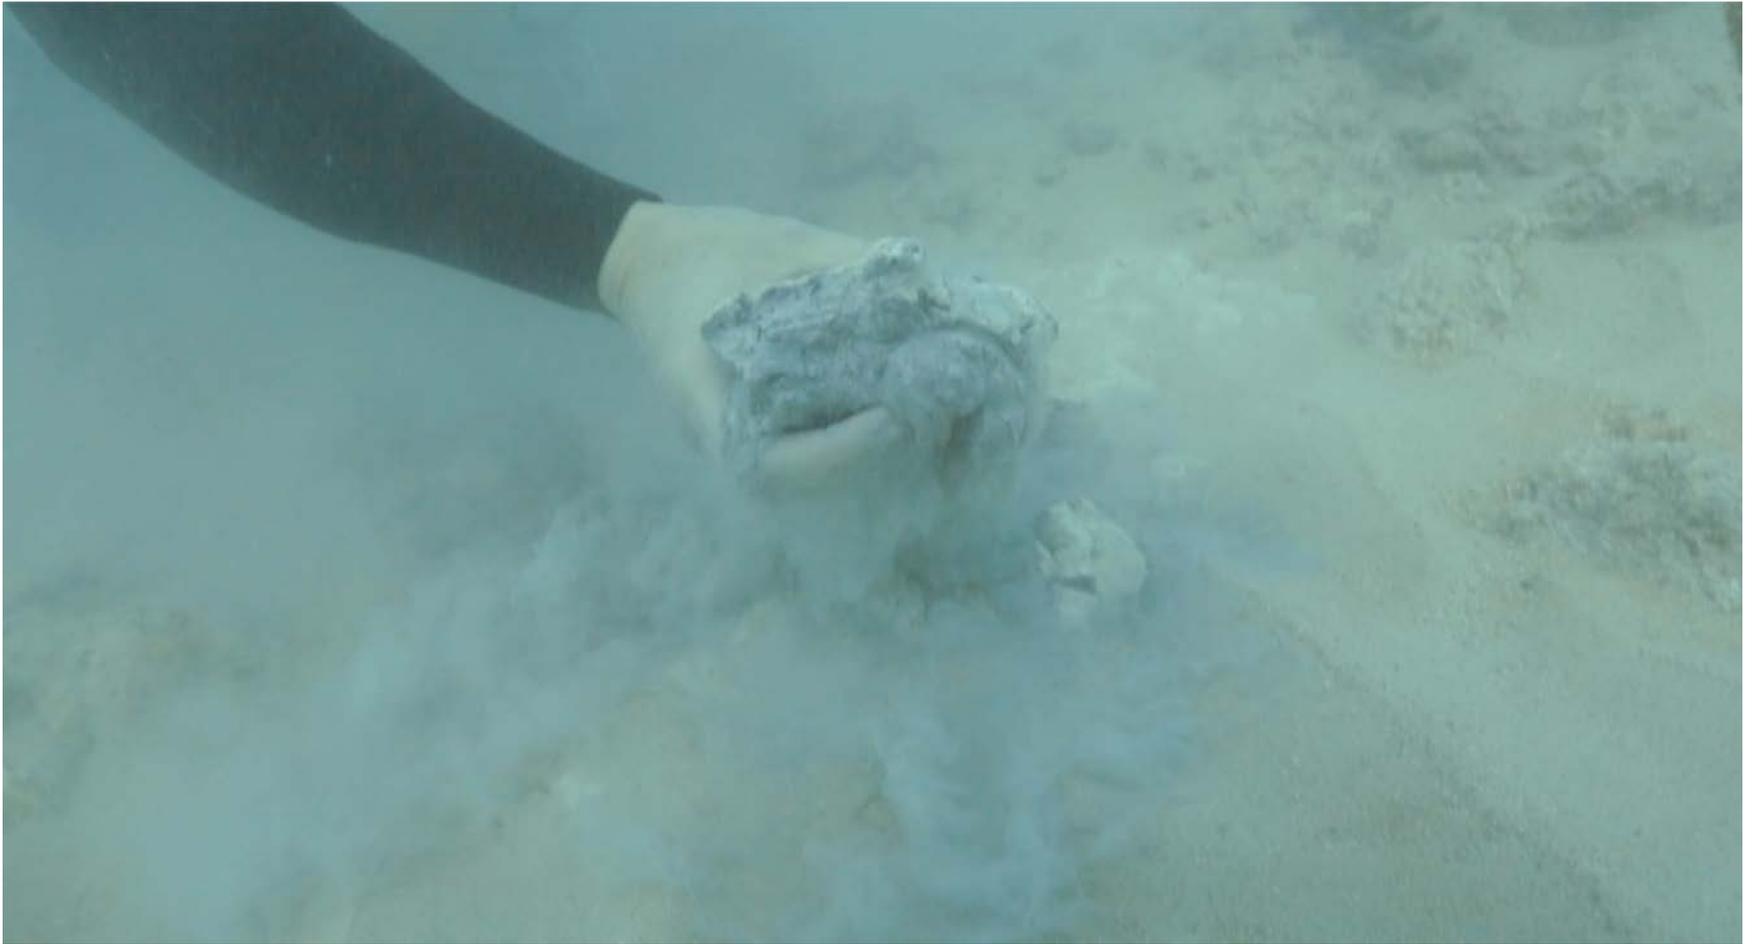
BBWK Photo 1/30/15

Deep sediments still cover the reef. They are clay-like and are not natural on the reef.

Recent (October) Dial Cordy report states that these sediments have dissipated. We found that this is not the case.

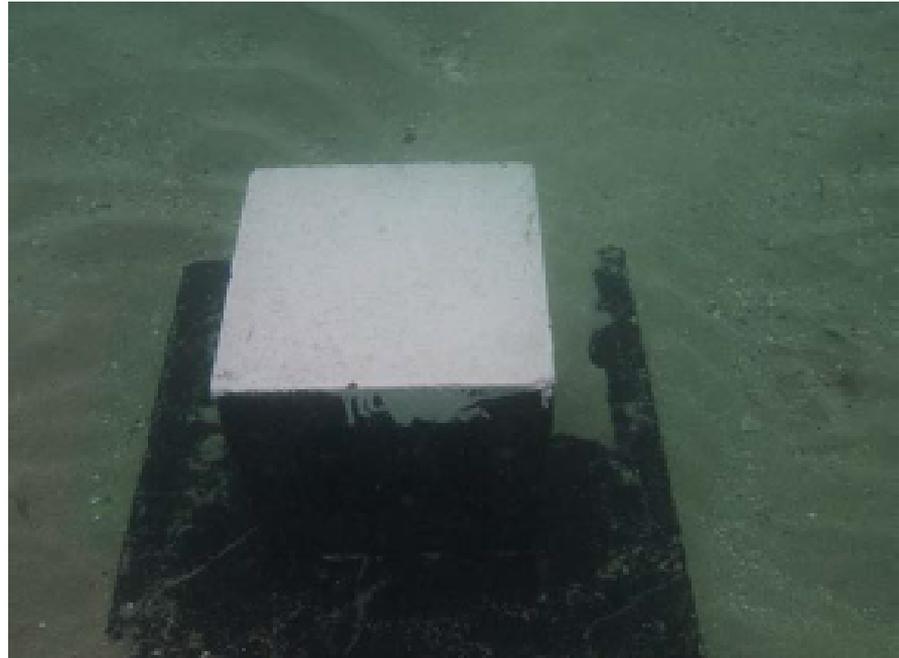
A net sediment accumulation block was placed at each site at the 10 m mark on Transect 2 (Figure 4). This block serves as the center point of the monitoring site for underwater navigational purposes. The sediment accumulation block consists of an 8 in. x 8 in. x 8 in. concrete block attached to the bottom with hydraulic cement. The block has one side coated with antifouling paint, which is oriented as the upper surface. The antifouling paint minimizes the bioaccumulation on the upper surface of the block which could interfere with sediment accumulation. Blocks were attached to exposed rock surfaces devoid of benthic fauna and no closer than 30 cm to any coral colony to assure no impact to living marine resources from the antifouling paint.

Figure 4 Sediment block used to monitor sediment accumulation at hardbottom and reef resources at hardbottom sites.

Sedimentation blocks do not appear to hold sediment falling from the water column, although that same sediment does settle on the habitat and benthos-below the block. The blocks sit 16-18 inches off the bottom, and it appears that this height is sufficient for them to be cleaned of material by water movement.

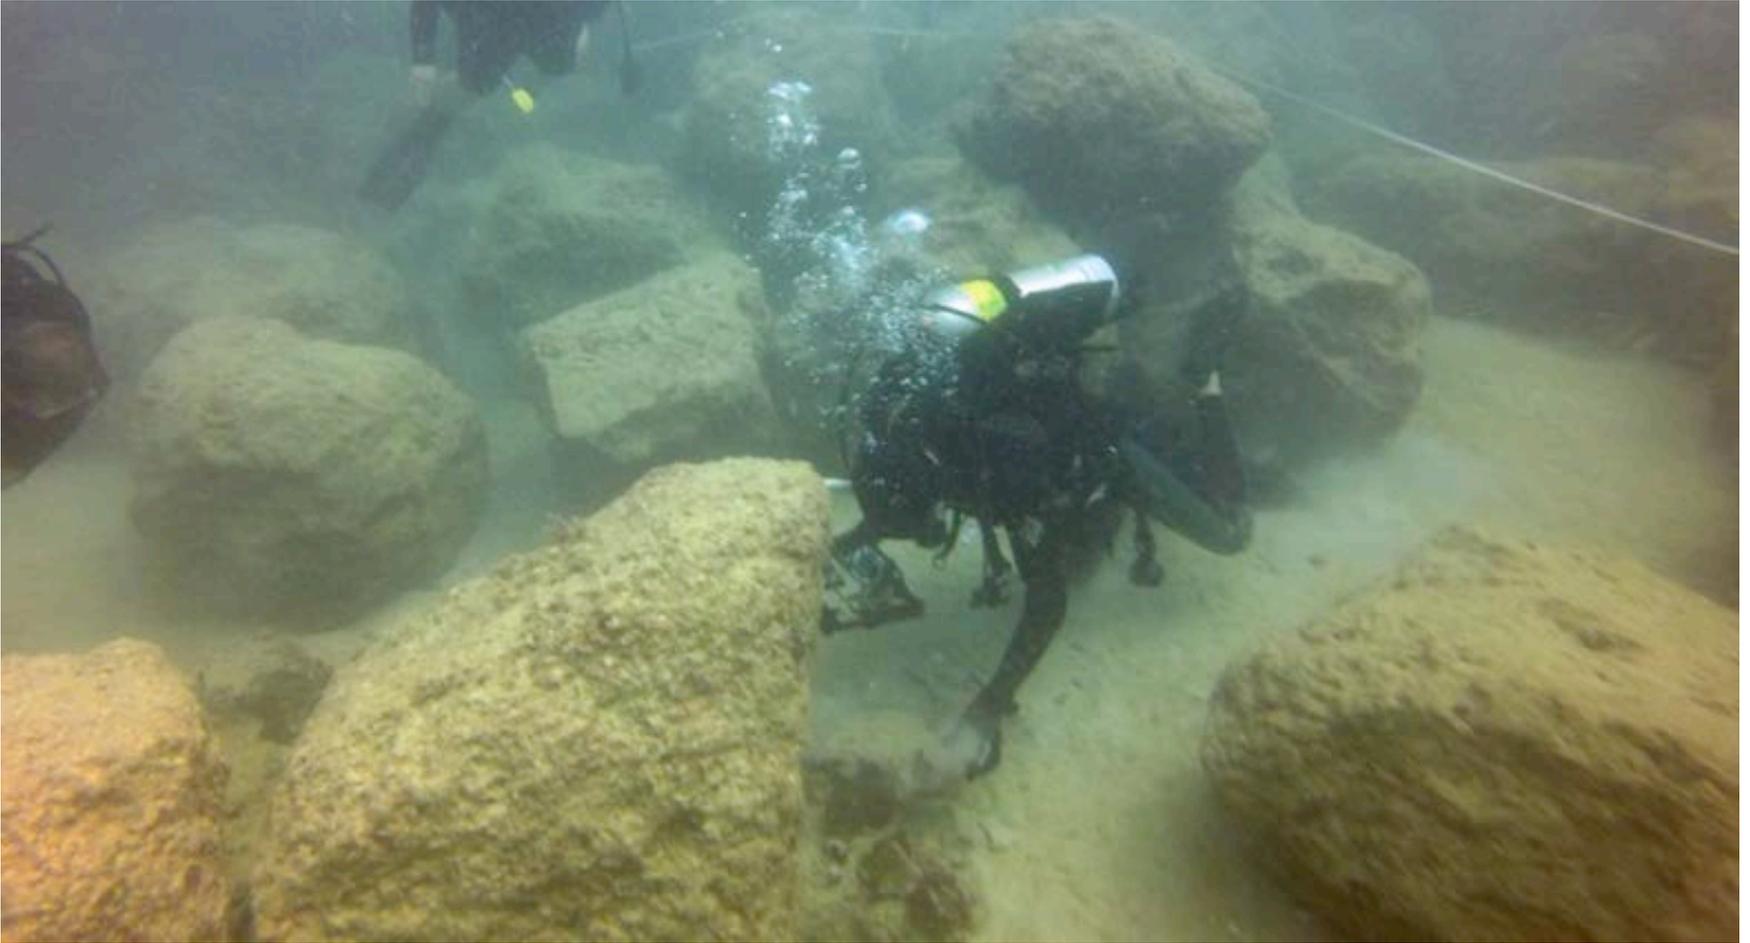
Mitigation boulders were placed on top of living corals, found by DEP divers

Photo from DEP July Warning Letter field notes reports:
Mitigation boulders for artificial reef habitat were placed on top of living coral.

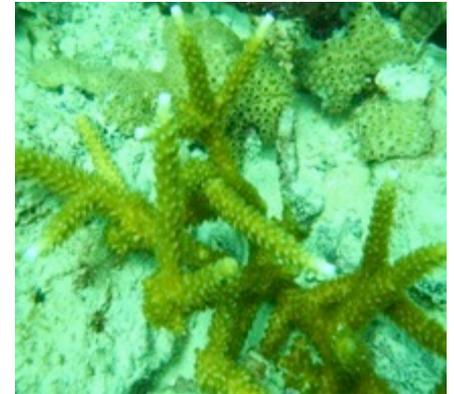
2010, pre-construction

Dial Cordy survey finds 31 corals in the indirect impact area (within 150m of the channel)

Corps tells NOAA the sedimentation will be minimal, NOAA says to move the 31 colonies and will OK the project in 2011 Biological Opinion

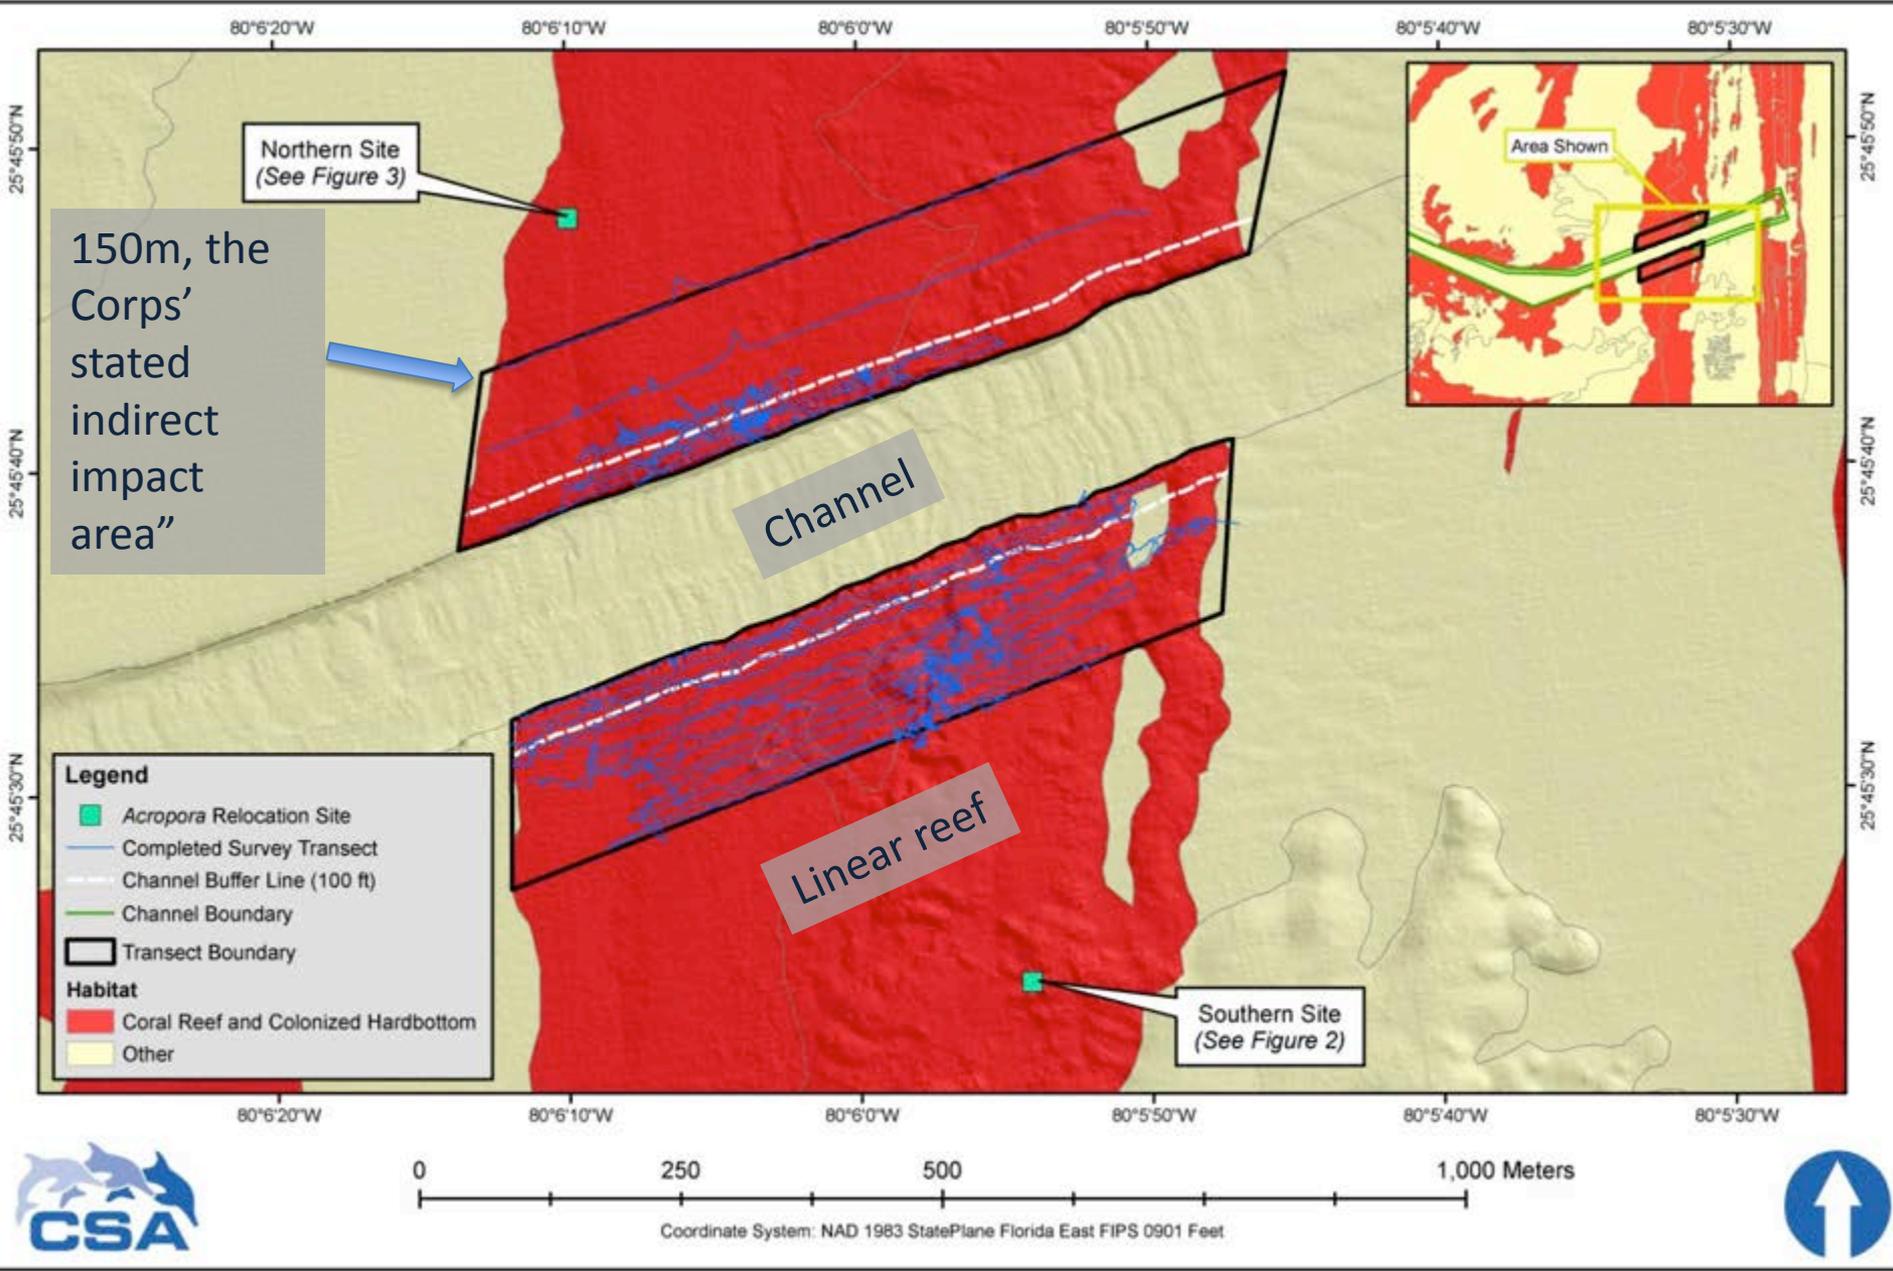
Blue lines are where the survey was completed in 2013

150m, the Corps' stated indirect impact area"

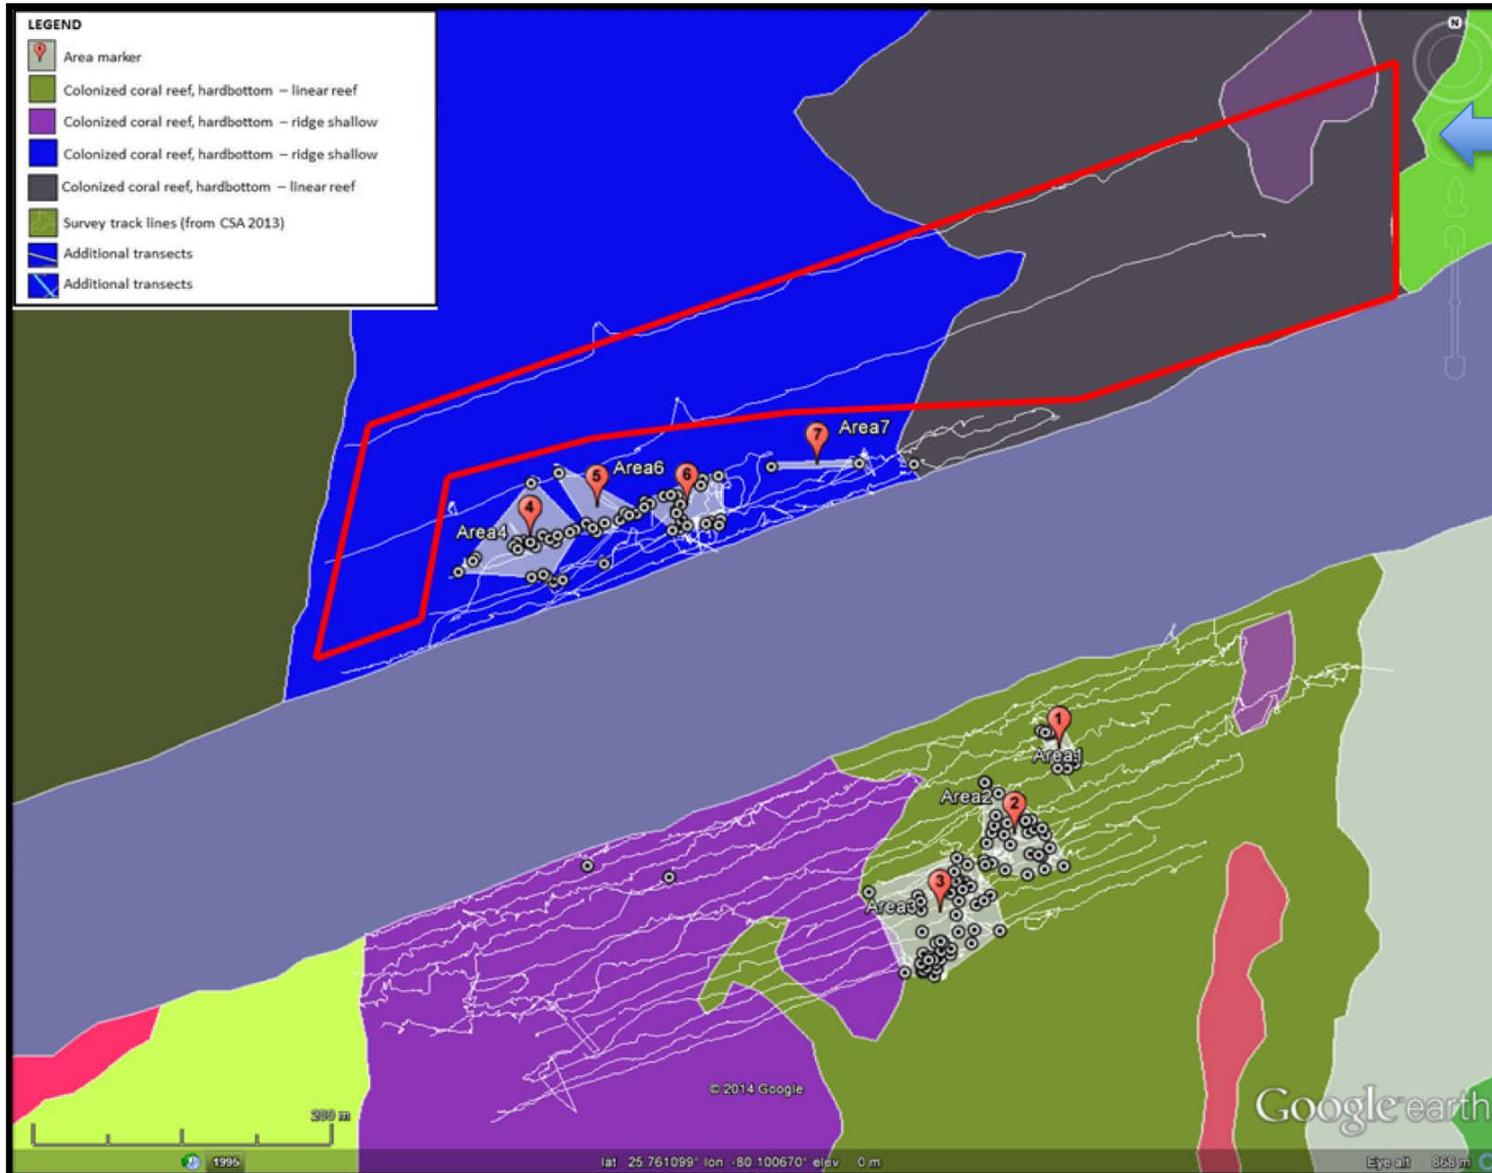
Area still lacking surveys for staghorn corals for sediment-ation impacts

Figure 2: The seven search areas identified by NOAA where *A. cervicornis* had been observed on the north and south sides of the Federal Channel. The orange markers show the center of each area. The red polygon in reef habitat to the north of the channel depicts areas with limited prior survey effort.

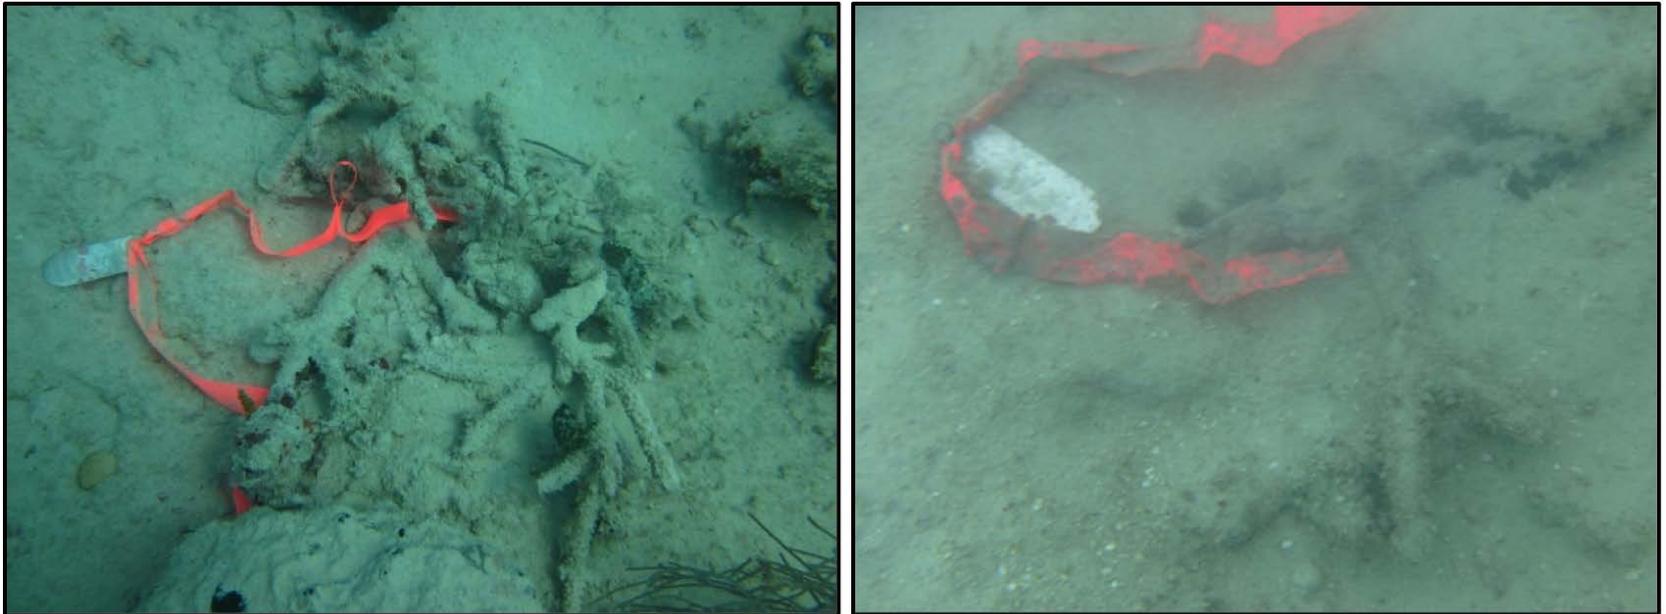
Figure 3: Colonies of *A. cervicornis* that had been tagged for monitoring [tag #22 (left)]. Tag #57 (right)] associated with a missing colony with a nearby dead coral as a result of burial by sediment.

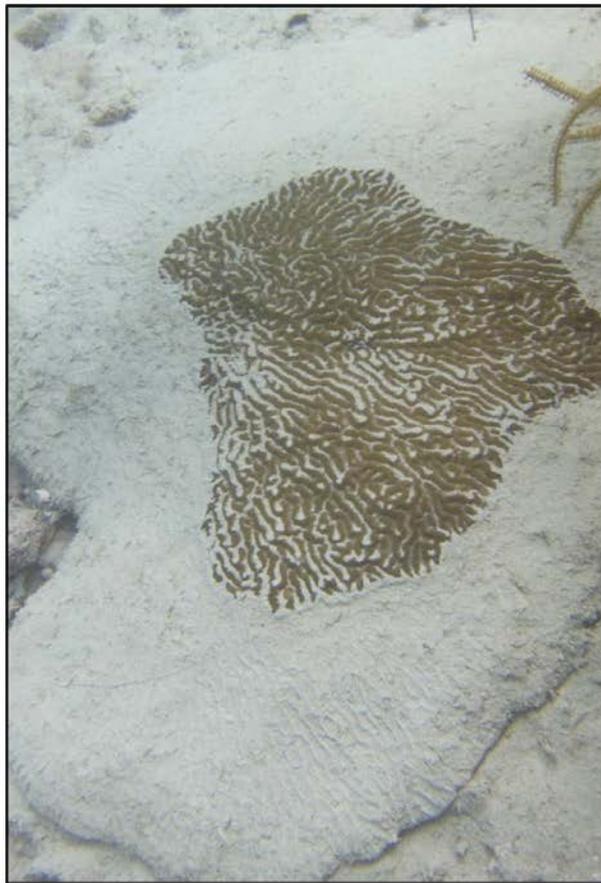
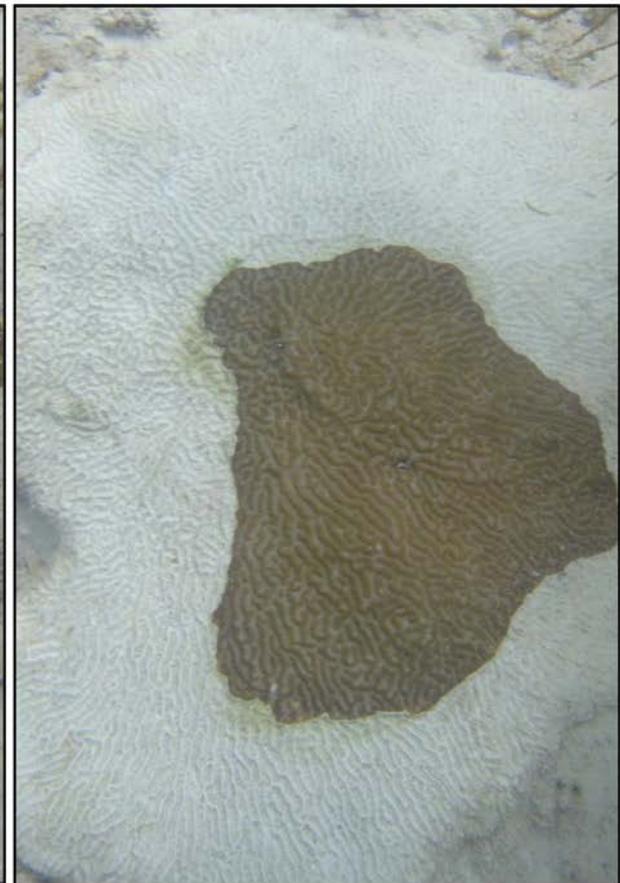
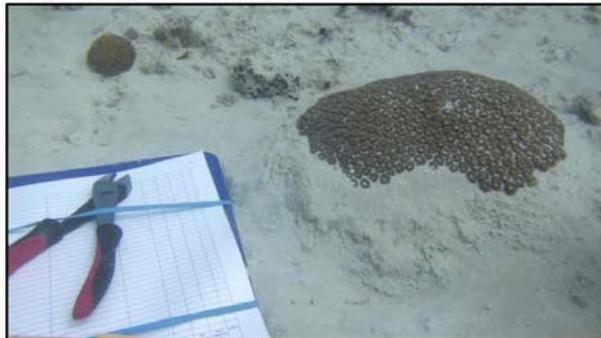
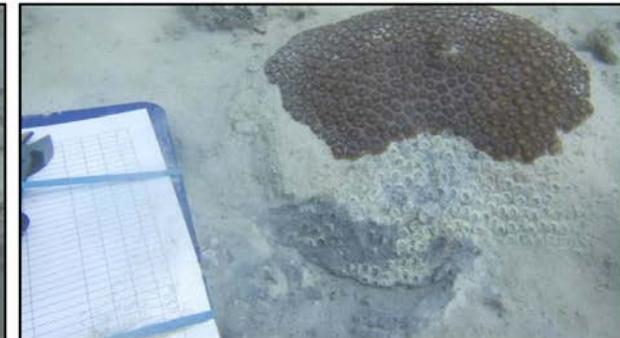
Figure 7: Coral colonies before (left photos) and after (right photos) divers cleared sediment from the corals showing accumulation and recent mortality (exposed white skeleton) along the lower portions of the colonies as a result of accumulation of fine and clay-like material (sedimentation)

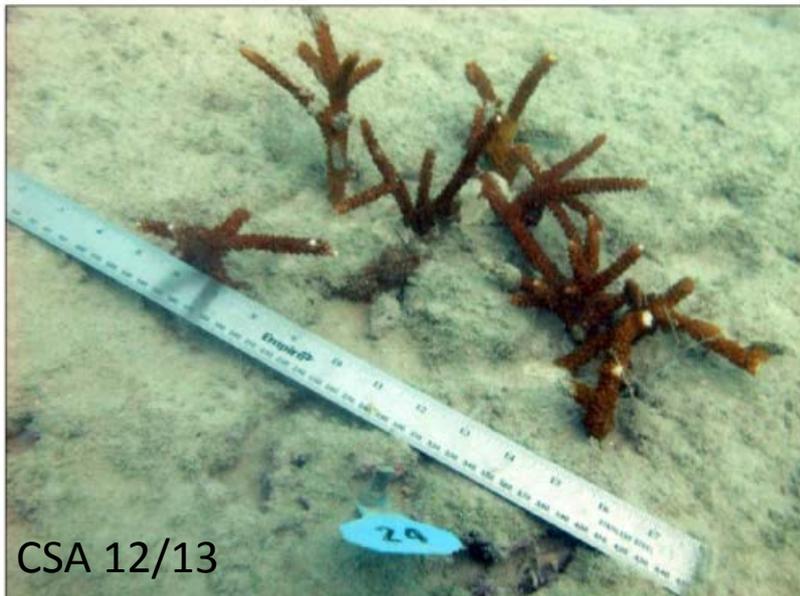
Photo C-24c. *Acropora cervicornis* colony #24 immediately post-reattachment.

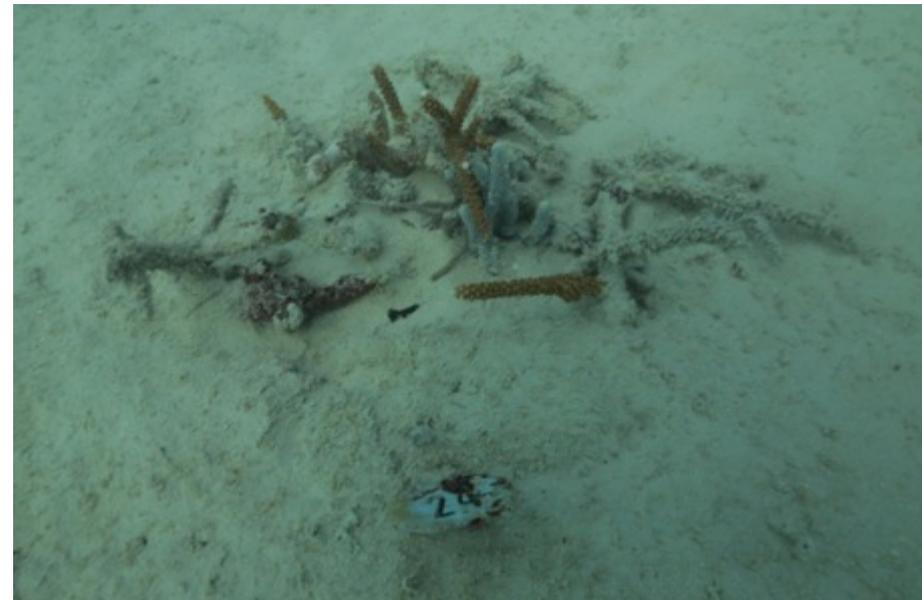
BBWK photo 1/30/15

Corals that were relocated to 250m north of the channel before construction have heavy and severe mortality

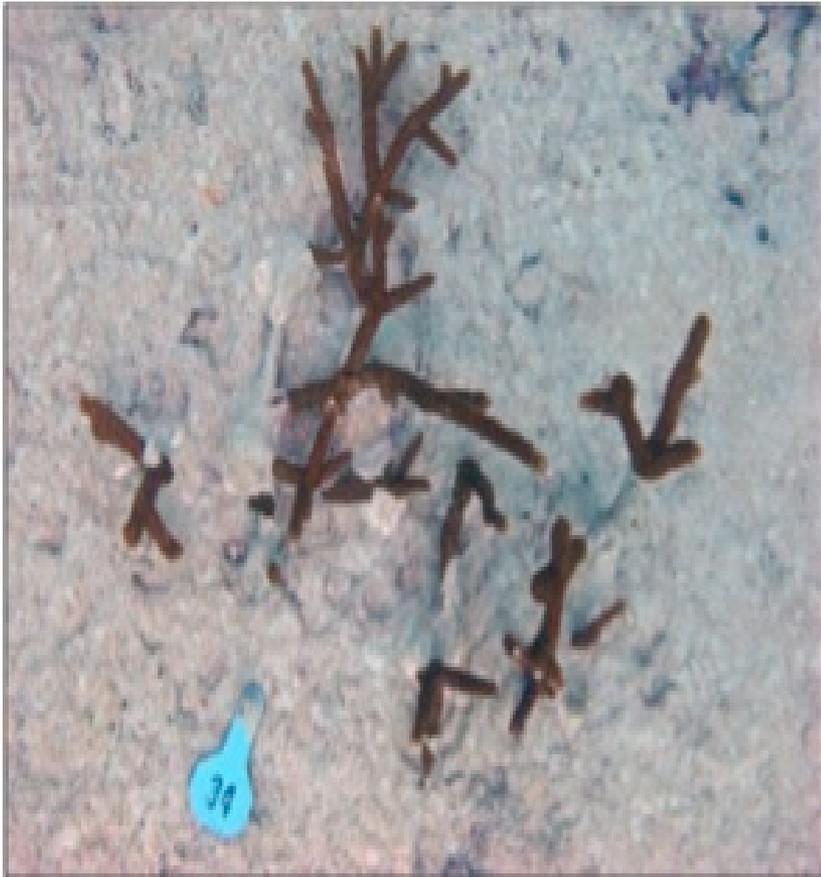
Photo C-34d. *Acropora cervicornis* colony #34 30 days post-reattachment. CSA 1/14/14

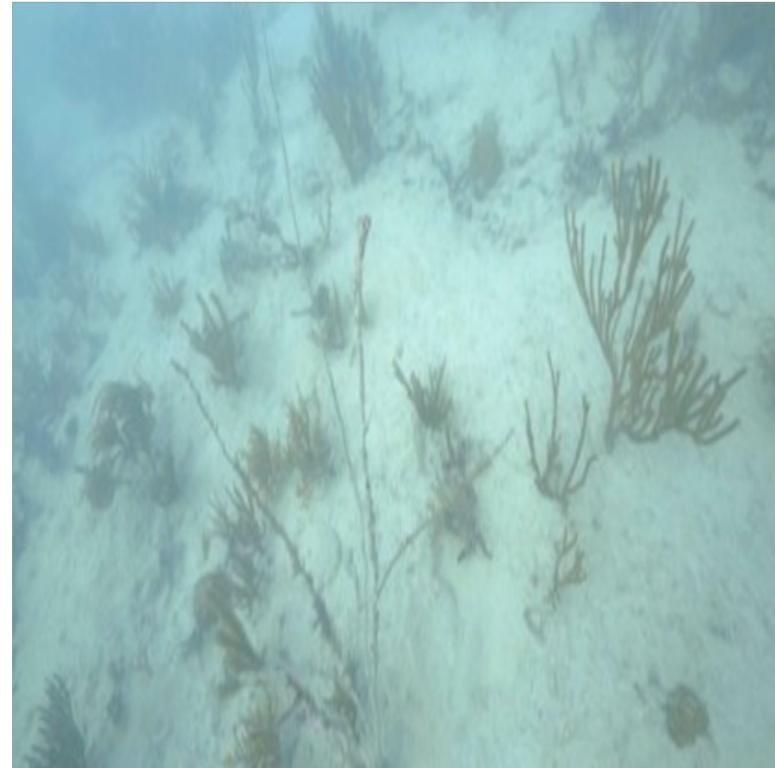
Recovery from sedimentation will be almost impossible for reef corals

- What is a “temporary” impact?
- Recovery will be hindered by:
 - the lack of hardbottom substrate for coral larvae to attach to
 - a lack of crustose coralline algae, which is red, encrusting algae that signals good habitat (reef) to juvenile corals

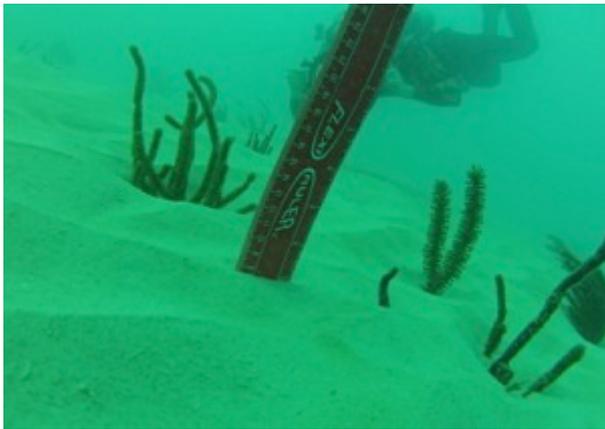
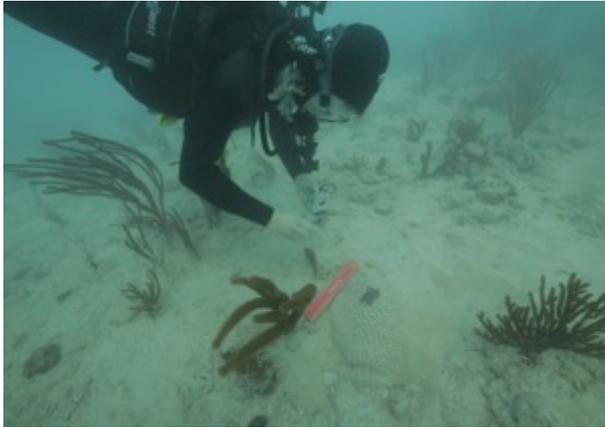
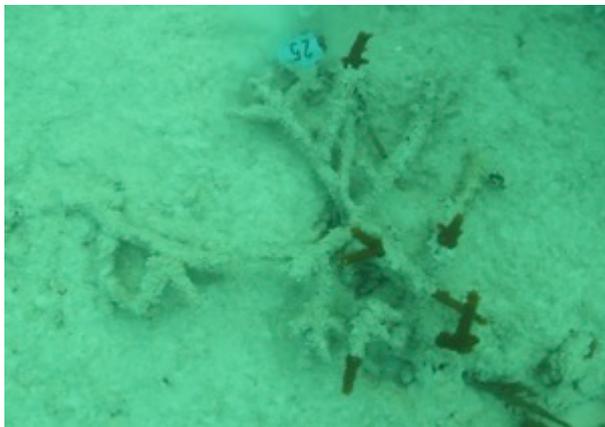
Conclusions in Miami

- Dense, fine, clay-like sediments are still present in the area, choking the reef

- **Sediment impacts extend far beyond the anticipated 150m “indirect impact area”**

- **The extent of the sediment damage has still not been fully delineated**

- The staghorn coral survey has not been completed on the North side of the channel. There are staghorns being impacted on the North side of the channel that were not surveyed or relocated. This is an ongoing “take”
